# Access Compliance Report

## Public Rights-of-Way

| Intersection ID: 18214 | Main Street: FERNCLIFF_RD | Cross Street: PROVIDENCE_RD | Location: NE |
| ADA ID: FCC513C6EE75 | Ramp Type: PerpDiag | Initial Pass/Fail: Fail | Overall Compliance: No |

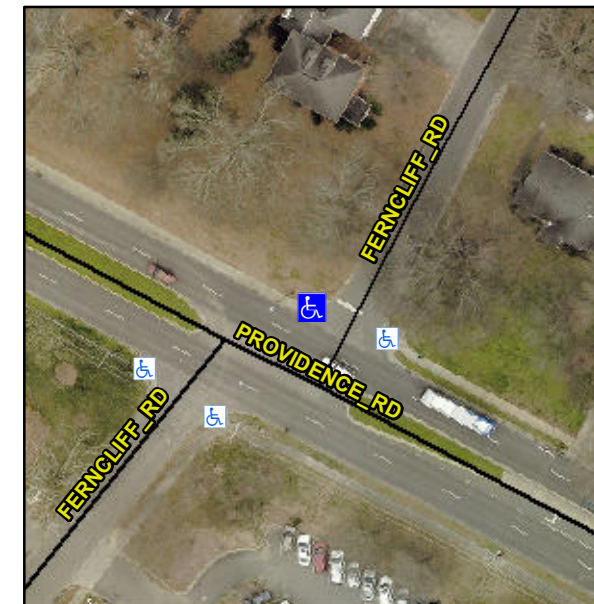
| | | Severity Score: 22.5 | |

**Not Found, R304.5.1, R304.2.2, R304.5.3**

| Compliance | Description | Data | Compliance | Description | Data |
|---|---|---|---|---|---|
| N/A | Ramp Length (in) | 60.0 | No | Ramp Slope (%) | 9.7 |
| No | Ramp Width (in) | 41.0 | No | Ramp XSlope (%) | 2.3 |

**Remove & Replace Curb Ramp With Two New Directional Ramps or Equivalent.**

Total Cost: \$ 3200.00
