Access Compliance Report

Public Rights-of-Way

(Curb Ramps)

Intersection ID: 13978	Main Street: EUCLID_AV	Cross Street: RENSSELAER_AV	Location: E
ADA ID: FCC63A9B093D	Ramp Type: ParaDiag	Initial Pass/Fail: Fail	Overall Compliance: No
Severity Score: 25			
Codes/Mitigation Info/Possible Solution		Field Measurements/Component Compliance

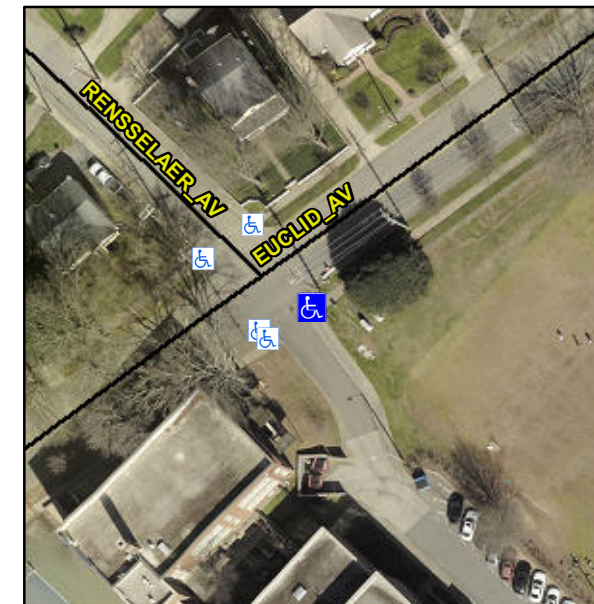
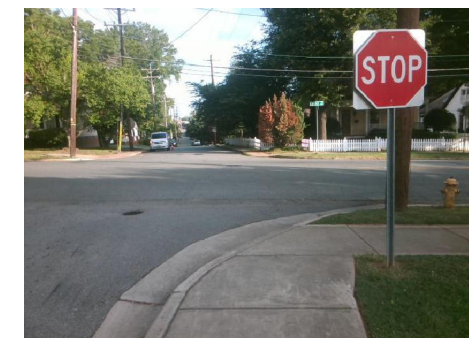
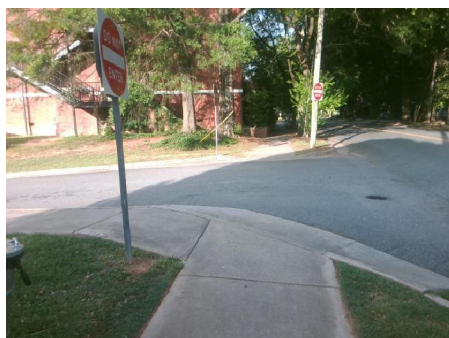
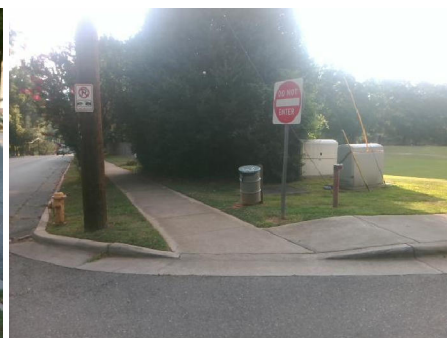
NO LT RAMP

Compliance	Description	Data	Compliance	Description	Data
N/A	Ramp Length LT (in)	N/A	N/A	Ramp Length RT (in)	48.0
N/A	Ramp Width LT (in)	N/A	Yes	Ramp Width RT (in)	60.0
N/A	Ramp Slope LT (%)	N/A	No	Ramp Slope RT (%)	12.4
N/A	Ramp XSlope LT (%)	N/A	Yes	Ramp XSlope RT (%)	1.2
N/A	Landing Length (in)	N/A	N/A	DWS Provided?	N/A
N/A	Landing Width (in)	N/A	N/A	DWS Contrast?	N/A
N/A	Landing Slope (%)	N/A	N/A	DWS Length (in)	N/A
N/A	Landing X Slope (%)	N/A	N/A	DWS Full Width?	N/A
N/A	Landing Curb? (Y/N)	N/A	N/A	DWS Offset (in)	N/A
N/A	Shared Landing?	N/A			
N/A	Gutter Ponding?	N/A	N/A	Gutter Slope (%)	N/A
N/A	Gutter Lip Ht (in)	N/A	N/A	Gutter X Slope (%)	N/A
N/A	Painted X Walk1?	No	N/A	Painted X Walk2?	No
	X Walk 1 Direction	To NW		X Walk 2 Direction	To SW
N/A	X Walk 1 Width (in)	N/A	N/A	X Walk 2 Width (in)	N/A
	X Walk 1 Slope (%)	1.4		X Walk 2 Slope (%)	2.6
	X Walk 1 X Slope (%)	4.4		X Walk 2 X Slope (%)	2.2
N/A	Ramp inside XWalk1?	N/A	N/A	Ramp inside XWalk2?	N/A

Road Slope (%)	7.0	N/A	Clear Space?	N/A
	Road X Slope (%)	3.4	N/A	Clear Space to XWalk (in)	N/A
N/A	Any Obstructions?	N/A	N/A	Storm Grate/Utility Hazard?	N/A
	Obstruction Type			Storm Grate/Utility Type	
		N/A			N/A
			Yes	Surface Condition? (G/P)	Good
			N/A	Curb Slope (%)	11.3

Possible Solutions:

Remove & Replace Curb Ramp With Two New Directional Ramps or Equivalent.
