Access Compliance Report

Public Rights-of-Way (Curb Ramps)

Intersection ID: N/A	Main Street: WOODFOX_DR	Cross Street: BURNING_TREE_DR	Location: SW
ADA ID: FCC89931936C	Ramp Type: Directional1	Initial Pass/Fail: Fail	Overall Compliance: No
		Severity Score: 50

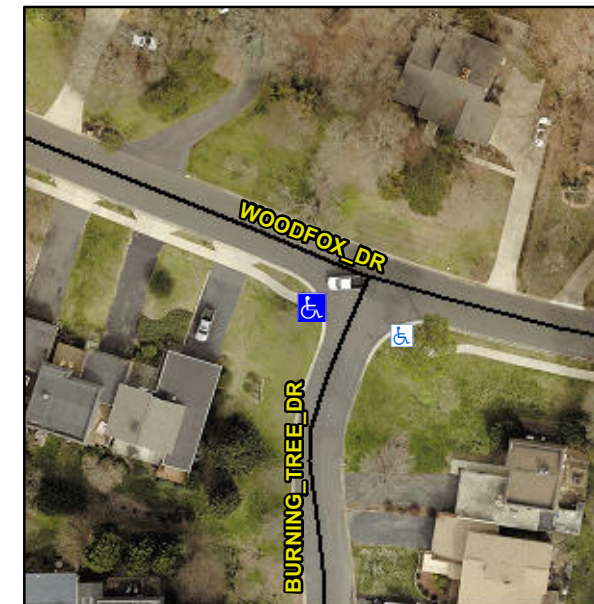
R304.2.2, R304.5.3

Compliance	Description	Data	Compliance	Description	Data
N/A	Ramp Length (in)	68.0	N/A	Grade Break?	N/A
Yes	Ramp Width (in)	60.0	N/A	Grade Break Slope (%)	0.0
No	Ramp Slope (%)	19.6	N/A	Grade Break XSlope (%)	0.0
No	Ramp XSlope (%)	11.6			
N/A	Flare Type LT	N/A	N/A	Flare Type RT	N/A
N/A	Flare Slope LT (%)	N/A	N/A	Flare Slope RT (%)	0.0
N/A	Flare Traversable LT?	N/A	N/A	Flare Traversable RT?	N/A
N/A	Landing Length (in)	0.0	N/A	DWS Provided?	N/A
N/A	Landing Width (in)	0.0	N/A	DWS Contrast?	N/A
N/A	Landing Slope (%)	0.0	N/A	DWS Length (in)	N/A
N/A	Landing X Slope (%)	0.0	N/A	DWS Full Width?	N/A
N/A	Landing Curb? (Y/N)	N/A	N/A	DWS Offset LT (in)	N/A
N/A	Shared Landing?	N/A	N/A	DWS Offset RT (in)	N/A
N/A	Gutter Ponding?	0.0	N/A	Gutter Slope (%)	N/A
N/A	Gutter Lip Ht (in)	0.0	N/A	Gutter X Slope (%)	N/A
N/A	Painted X Walk1?	No		Road Slope (%)	2.7
	X Walk 1 Direction	To E		Road X Slope (%)	8.8
	X Walk 1 Width (in)	N/A		Clear Space?	N/A

X Walk 1 Slope (%)	2.7	N/A	Clear Space to XWalk (in)	N/A
	X Walk 1 X Slope (%)	8.8	N/A	Storm Grate/Utility Hazard?	N/A
N/A	Ramp inside XWalk1?	N/A		Storm Grate/Utility Type	
N/A	Any Obstructions?	N/A			N/A
	Obstruction Type		Yes	Surface Condition? (G/P)	Good
			N/A	Curb Slope (%)	9.7

Remove & Replace Entire Ramp.
