Access Compliance Report

Public Rights-of-Way

(Curb Ramps)

Intersection ID: 52150	Main Street: ENGLAND_ST	Cross Street: ARROWOOD_STATION_DR	Location: NE
ADA ID: FCDB7B7B85F8	Ramp Type: PerpDiag	Initial Pass/Fail: Fail	Overall Compliance: No
Codes/Mitigation Info/Possible Solution		Field Measurements/Component Compliance	
Severity Score: 12.5

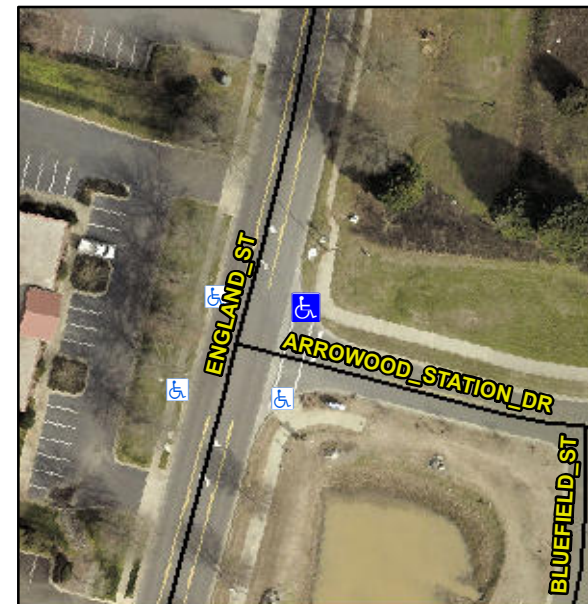
Not Found, R304.2.2

Compliance	Description	Data	Compliance	Description	Data
N/A	Ramp Length (in)	56.0	No	Ramp Slope (%)	11.0
Yes	Ramp Width (in)	48.0	Yes	Ramp XSlope (%)	0.9
N/A	Flare Type LT	N/A	N/A	Flare Type RT	N/A
N/A	Flare Slope LT (%)	N/A	N/A	Flare Slope RT (%)	N/A
N/A	Flare Traversable LT?	N/A	N/A	Flare Traversable RT?	N/A
N/A	Landing Length (in)	N/A	N/A	DWS Provided?	N/A
N/A	Landing Width (in)	N/A	N/A	DWS Contrast?	N/A
N/A	Landing Slope (%)	N/A	N/A	DWS Length (in)	N/A
N/A	Landing X Slope (%)	N/A	N/A	DWS Full Width?	N/A
N/A	Landing Curb? (Y/N)	N/A	N/A	DWS Offset (in)	N/A
N/A	Shared Landing?	N/A			
N/A	Gutter Ponding?	N/A	N/A	Gutter Slope (%)	N/A
N/A	Gutter Lip Ht (in)	N/A	N/A	Gutter X Slope (%)	N/A
N/A	Painted X Walk1?	No	N/A	Painted X Walk2?	No
	X Walk 1 Direction	To W		X Walk 2 Direction	To SW
N/A	X Walk 1 Width (in)	N/A	N/A	X Walk 2 Width (in)	N/A
	X Walk 1 Slope (%)	1.4		X Walk 2 Slope (%)	0.7
	X Walk 1 X Slope (%)	0.6		X Walk 2 X Slope (%)	0.5

N/A	Ramp inside XWalk1?	N/A	N/A	Ramp inside XWalk2?	N/A
	Road Slope (%)	0.0	N/A	Clear Space?	N/A
	Road X Slope (%)	0.4	N/A	Clear Space to XWalk (in)	N/A
N/A	Any Obstructions?	N/A	N/A	Storm Grate/Utility Hazard?	N/A
	Obstruction Type			Storm Grate/Utility Type	
		N/A			N/A
			Yes	Surface Condition? (G/P)	Good

Remove & Replace Curb Ramp With Two New Directional Ramps or Equivalent.

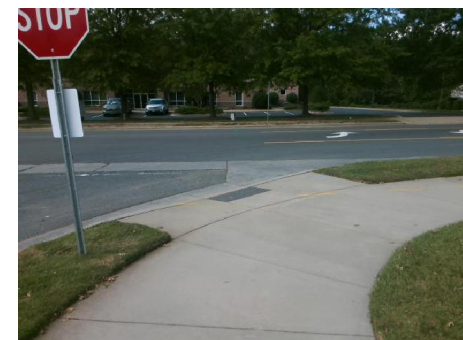
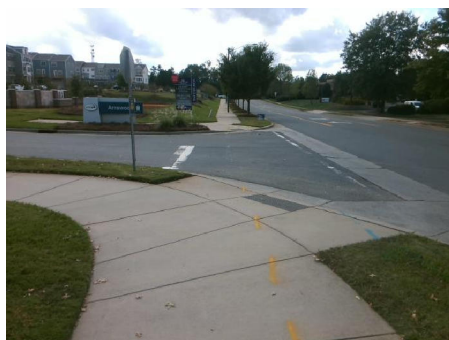
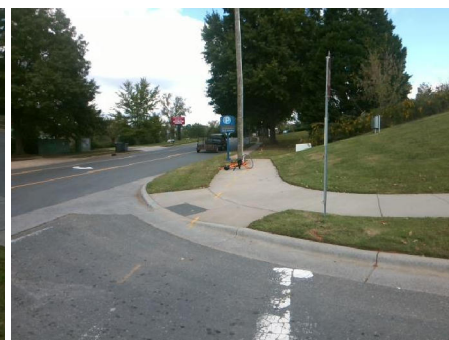
N/A
