# Access Compliance Report

## Public Rights-of-Way

### (Curb Ramps)

Intersection ID: 25370	Main Street: PEVERELL_LN	Cross Street: PROVIDENCE_PLANTATION_LN	Location: S
ADA ID: FCDB8C759984	Ramp Type: Perp	Initial Pass/Fail: Fail	Overall Compliance: No
Severity Score: 36.25			
Codes/Mitigation Info/Possible Solution		Field Measurements/Component Compliance

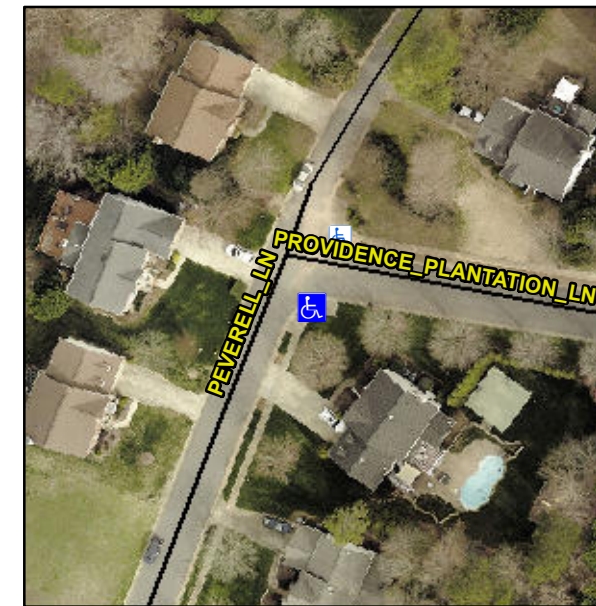
**Not Found, R304.5.1, R304.5.3**

Compliance	Description	Data	Compliance	Description	Data
N/A	Ramp Length (in)	96.0	Yes	Ramp Slope (%)	5.5
No	Ramp Width (in)	25.0	No	Ramp XSlope (%)	4.1
N/A	Flare Type LT	N/A	N/A	Flare Type RT	N/A
N/A	Flare Slope LT (%)	N/A	N/A	Flare Slope RT (%)	N/A
N/A	Flare Traversable LT?	N/A	N/A	Flare Traversable RT?	N/A
N/A	Landing Length (in)	N/A	N/A	DWS Provided?	N/A
N/A	Landing Width (in)	N/A	N/A	DWS Contrast?	N/A
N/A	Landing Slope (%)	N/A	N/A	DWS Length (in)	N/A
N/A	Landing X Slope (%)	N/A	N/A	DWS Full Width?	N/A
N/A	Landing Curb? (Y/N)	N/A	N/A	DWS Offset (in)	N/A
N/A	Shared Landing?	N/A			
N/A	Gutter Ponding?	N/A	N/A	Gutter Slope (%)	N/A
N/A	Gutter Lip Ht (in)	N/A	N/A	Gutter X Slope (%)	N/A
N/A	Painted X Walk1?	No	N/A	Painted X Walk2?	N/A
	X Walk 1 Direction	To NE		X Walk 2 Direction	N/A
N/A	X Walk 1 Width (in)	N/A	N/A	X Walk 2 Width (in)	N/A
	X Walk 1 Slope (%)	3.3		X Walk 2 Slope (%)	N/A
	X Walk 1 X Slope (%)	1.1		X Walk 2 X Slope (%)	N/A

N/A	Ramp inside XWalk1?	N/A	N/A	Ramp inside XWalk2?	N/A
	Road Slope (%)	N/A	N/A	Clear Space?	N/A
	Road X Slope (%)	N/A	N/A	Clear Space to XWalk (in)	N/A
N/A	Any Obstructions?	N/A	N/A	Storm Grate/Utility Hazard?	N/A
	Obstruction Type			Storm Grate/Utility Type	
		N/A			N/A
			Yes	Surface Condition? (G/P)	Good

**Remove & Replace Entire Ramp.**

Total Cost: \$ 1850.00
