Access Compliance Report Public Rights-of-Way (Curb Ramps)

Intersection ID: 48773 Main Street: OLD_FORESTER_LN Cross Street: SONOMA_VALLEY_DR Location: SE

ADA ID: FCDE586961A9 Ramp Type: PerpDiag Initial Pass/Fail: Fail Overall Compliance: No Severity Score: 8.75

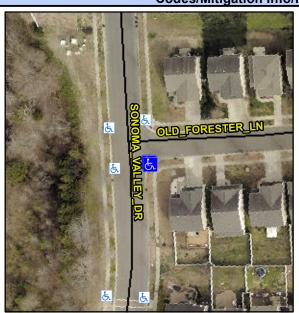
Not Found, R304.5.1

Compliance Description		Data	Comp	liance Description	n Data	
N/A	Ramp Length (in)	71.0	Yes	Ramp Slope (%)	5.7	
No	Ramp Width (in)	47.5	Yes	Ramp XSlope (%)	1.6	
N/A	Flare Type LT	N/A	N/A	Flare Type RT	N/A	
N/A	Flare Slope LT (%)	N/A	N/A	Flare Slope RT (%)	N/A	
N/A	Flare Traversable LT?	N/A	N/A	Flare Traversable RT?	N/A	
N/A	Landing Length (in)	N/A	N/A	DWS Provided?	N/A	
N/A	Landing Width (in)	N/A	N/A	DWS Contrast?	N/A	
N/A	Landing Slope (%)	N/A	N/A	DWS Length (in)	N/A	
N/A	Landing X Slope (%)	N/A	N/A	DWS Full Width?	N/A	
N/A	Landing Curb? (Y/N)	N/A	N/A	DWS Offset (in)	N/A	
N/A	Shared Landing?	N/A				
N/A	Gutter Ponding?	N/A	N/A	Gutter Slope (%)	N/A	
N/A	Gutter Lip Ht (in)	N/A	N/A	Gutter X Slope (%)	N/A	
N/A	Painted X Walk1?	No	N/A	Painted X Walk2?	No	
	X Walk 1 Direction	To N		X Walk 2 Direction	To W	
N/A	X Walk 1 Width (in)	N/A	N/A	X Walk 2 Width (in)	N/A	
	X Walk 1 Slope (%)	2.3		X Walk 2 Slope (%)	4.0	
	X Walk 1 X Slope (%)	1.4		X Walk 2 X Slope (%)	0.9

N/A	Ramp inside XWalk1?	N/A	N/A	Ramp inside XWalk2?	N/A	
	Road Slope (%)	1.5	N/A	Clear Space?	N/A	
	Road X Slope (%)	0.3	N/A	Clear Space to XWalk (in)	N/A	
N/A	Any Obstructions?	N/A	N/A	Storm Grate/Utility Hazard?	N/A	
	Obstruction Type			Storm Grate/Utility Type		
		N/A			N/A	
			Yes	Surface Condition? (G/P)	Good

Remove & Replace Curb Ramp With Two New Directional Ramps or Equivalent.
