## Access Compliance Report Public Rights-of-Way (Curb Ramps)

Intersection ID: 29395 Main Street: REEDY\_PLANTATION\_RD Cross Street: SILVERFIELD\_LN Location: SE

ADA ID: FCE1DA87B096 Ramp Type: BlendTrans1 Initial Pass/Fail: Fail Overall Compliance: No Severity Score: 12.5

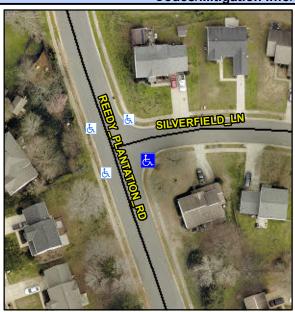
Field Measure	ements/C	ompo	nent Compliance	
	Comp	Compliance Description		Comp	liance Description	Data
	N/A	Ramp Length (in)	44.0	Yes	BlendTrans Slope (%)	2.6
	Yes	Ramp Width (in)	48.0	No	BlendTrans XSlope (%)	5.4
	N/A	Flare Type LT	N/A	N/A	Flare Type RT	N/A
	N/A	Flare Slope LT (%)	N/A	N/A	Flare Slope RT (%)	N/A
	N/A	Flare Traversable LT?	N/A	N/A	Flare Traversable RT?	N/A
	N/A	Landing Length (in)	N/A	N/A	DWS Provided?	N/A
	N/A	Landing Width (in)	N/A	N/A	DWS Contrast?	N/A
	N/A	Landing Slope (%)	N/A	N/A	DWS Length (in)	N/A
	N/A	Landing X Slope (%)	N/A	N/A	DWS Full Width?	N/A
	N/A	Landing Curb? (Y/N)	N/A	N/A	DWS Offset (in)	N/A
	N/A	Shared Landing?	N/A			
	N/A	Gutter Ponding?	N/A	N/A	Gutter Slope (%)	N/A
	N/A	Gutter Lip Ht (in)	N/A	N/A	Gutter X Slope (%)	N/A
	N/A	Painted X Walk1?	No	N/A	Painted X Walk2?	No
		X Walk 1 Direction	To NW		X Walk 2 Direction	To W
		X Walk 1 Width (in)	N/A		X Walk 2 Width (in)	N/A

X Walk 1 Slope (%)	6.4		X Walk 2 Slope (%)	2.7
		X Walk 1 X Slope (%)	0.0		X Walk 2 X Slope (%)	7.0
	N/A	Ramp inside XWalk1?	N/A	N/A	Ramp inside XWalk2?	N/A
		Road Slope (%)	2.6		Clear Space?	N/A
		Road X Slope (%)	5.3	N/A	Clear Space to XWalk (in)	N/A
	N/A	Any Obstructions?	N/A	N/A	Storm Grate/Utility Hazard?	N/A
		Obstruction Type			Storm Grate/Utility Type	
			N/A			N/A
				Yes	Surface Condition? (G/P)	Good
die				N/A	Curb Slope (%)	N/A

Remove & Replace Curb Ramp With
Two New Directional Ramps or
Equivalent.

R304.5.3

Total Cost: \$ 3200.00
