Access Compliance Report

Public Rights-of-Way

(Curb Ramps)

Intersection ID: 10161	Main Street: E_35TH_ST	Cross Street: YADKIN_AV	Location: N
ADA ID: FCEDD1ECB482	Ramp Type: PerpDiag	Initial Pass/Fail: Fail	Overall Compliance: No
			Severity Score: 46.25

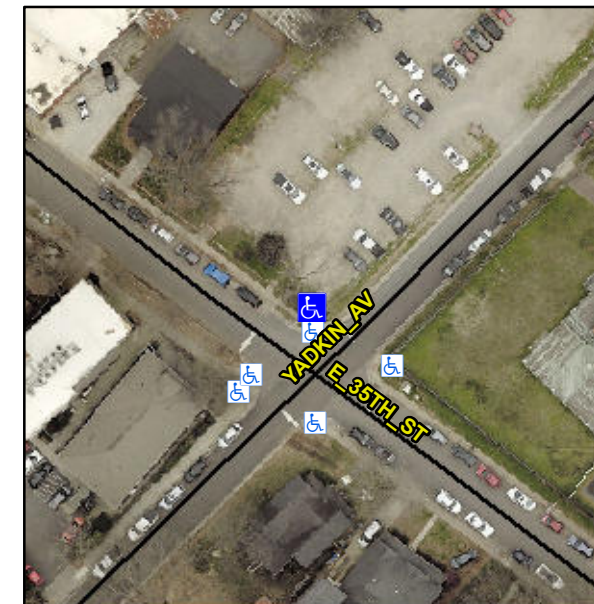
Not Found, R304.5.1, R304.2.2, R304.5.3

Compliance	Description	Data	Compliance	Description	Data
N/A	Ramp Length (in)	52.0	No	Ramp Slope (%)	9.7
No	Ramp Width (in)	47.0	No	Ramp XSlope (%)	8.3
N/A	Flare Type LT	N/A	N/A	Flare Type RT	N/A
N/A	Flare Slope LT (%)	N/A	N/A	Flare Slope RT (%)	N/A
N/A	Flare Traversable LT?	N/A	N/A	Flare Traversable RT?	N/A
N/A	Landing Length (in)	N/A	N/A	DWS Provided?	N/A
N/A	Landing Width (in)	N/A	N/A	DWS Contrast?	N/A
N/A	Landing Slope (%)	N/A	N/A	DWS Length (in)	N/A
N/A	Landing X Slope (%)	N/A	N/A	DWS Full Width?	N/A
N/A	Landing Curb? (Y/N)	N/A	N/A	DWS Offset (in)	N/A
N/A	Shared Landing?	N/A			
N/A	Gutter Ponding?	N/A	N/A	Gutter Slope (%)	N/A
N/A	Gutter Lip Ht (in)	N/A	N/A	Gutter X Slope (%)	N/A
N/A	Painted X Walk1?	No	N/A	Painted X Walk2?	No
	X Walk 1 Direction	To SW		X Walk 2 Direction	To SE
N/A	X Walk 1 Width (in)	N/A	N/A	X Walk 2 Width (in)	N/A
	X Walk 1 Slope (%)	2.5		X Walk 2 Slope (%)	0.2
	X Walk 1 X Slope (%)	0.8		X Walk 2 X Slope (%)	6.9

N/A	Ramp inside XWalk1?	N/A	N/A	Ramp inside XWalk2?	N/A
	Road Slope (%)	8.1	N/A	Clear Space?	N/A
	Road X Slope (%)	0.4	N/A	Clear Space to XWalk (in)	N/A
N/A	Any Obstructions?	N/A	N/A	Storm Grate/Utility Hazard?	N/A
	Obstruction Type			Storm Grate/Utility Type	
		N/A			N/A
			Yes	Surface Condition? (G/P)	Good

Remove & Replace Curb Ramp With Two New Directional Ramps or Equivalent.
