# Access Compliance Report

## Public Rights-of-Way

### (Curb Ramps)

| Intersection ID: 44295 | Main Street: PEACHWOOD_DR | Cross Street: ROCKWOOD_RD | Location: NW |

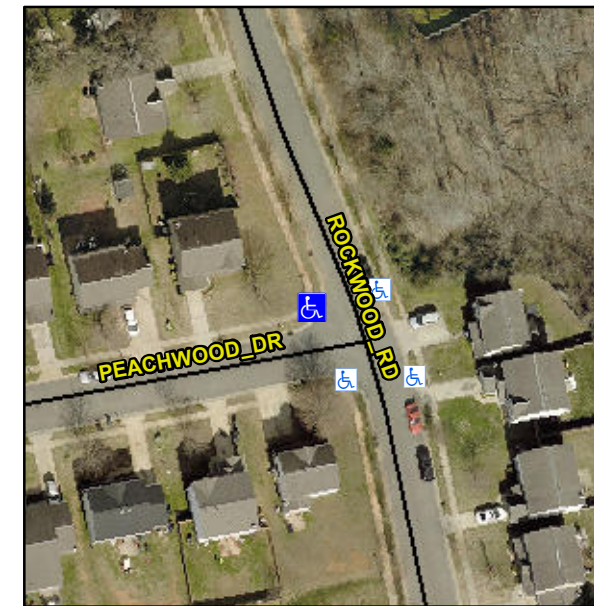
**Not Found, R304.2.1, R304.2.2-Perp, R304.3.2-Para, R304.5.3, R305, R302.7.2, R304.5.4**

| Compliance | Description | Data | Compliance | Description | Data |
|---|---|---|---|---|---|
| No | Landing Length (in) | 47.5 | No | DWS Provided? | No |
| No | Landing Slope (%) | 4.3 | N/A | DWS Length (in) | N/A |
| No | Landing X Slope (%) | 2.4 | N/A | DWS Full Width? | No |
| Yes | Gutter Ponding? | No | No | Gutter Slope (%) | 11.6 |
| No | Gutter Lip Ht (in) | 1.0 | Yes | Gutter X Slope (%) | 0.7 |

**Remove & Replace Curb Ramp With Two New Directional Ramps or Equivalent. Remove & Replace Gutter.**
