Access Compliance Report

Public Rights-of-Way

(Curb Ramps)

Intersection ID: 10709	Main Street: MORSON_ST	Cross Street: PRYOR_ST	Location: SW
ADA ID: FCFB081C24BD	Ramp Type: PerpDiag	Initial Pass/Fail: Fail	Overall Compliance: No
		Severity Score: 10

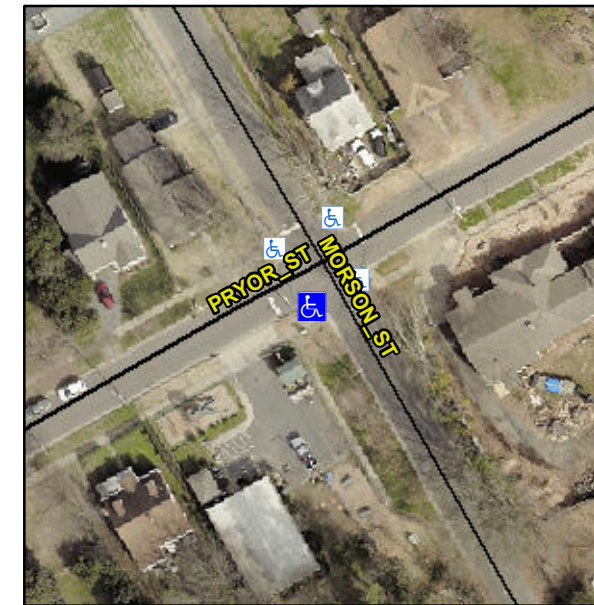
Compliance	Description	Data	Compliance	Description	Data
N/A	Ramp Length (in)	86.0	Yes	Ramp Slope (%)	5.2
No	Ramp Width (in)	47.5	No	Ramp XSlope (%)	2.3
N/A	Flare Type LT	N/A	N/A	Flare Type RT	N/A
N/A	Flare Slope LT (%)	N/A	N/A	Flare Slope RT (%)	N/A
N/A	Flare Traversable LT?	N/A	N/A	Flare Traversable RT?	N/A
N/A	Landing Length (in)	N/A	N/A	DWS Provided?	N/A
N/A	Landing Width (in)	N/A	N/A	DWS Contrast?	N/A
N/A	Landing Slope (%)	N/A	N/A	DWS Length (in)	N/A
N/A	Landing X Slope (%)	N/A	N/A	DWS Full Width?	N/A
N/A	Landing Curb? (Y/N)	N/A	N/A	DWS Offset (in)	N/A
N/A	Shared Landing?	N/A			
N/A	Gutter Ponding?	N/A	N/A	Gutter Slope (%)	N/A
N/A	Gutter Lip Ht (in)	N/A	N/A	Gutter X Slope (%)	N/A
N/A	Painted X Walk1?	No	N/A	Painted X Walk2?	No
	X Walk 1 Direction	To E		X Walk 2 Direction	To N
N/A	X Walk 1 Width (in)	N/A	N/A	X Walk 2 Width (in)	N/A
	X Walk 1 Slope (%)	4.4		X Walk 2 Slope (%)	4.2
	X Walk 1 X Slope (%)	0.1		X Walk 2 X Slope (%)	3.6

N/A	Ramp inside XWalk1?	N/A	N/A	Ramp inside XWalk2?	N/A
	Road Slope (%)	2.4	N/A	Clear Space?	N/A
	Road X Slope (%)	4.9	N/A	Clear Space to XWalk (in)	N/A
N/A	Any Obstructions?	N/A	N/A	Storm Grate/Utility Hazard?	N/A
	Obstruction Type			Storm Grate/Utility Type	
		N/A			N/A
		Yes		Surface Condition? (G/P)	Good

Remove & Replace Curb Ramp With Two New Directional Ramps or Equivalent.
