# Access Compliance Report

## Public Rights-of-Way

### (Curb Ramps)

Intersection ID: 14511	Main Street: OLD_STEELE_CREEK_RD	Cross Street: W_TYVOLA_RD	Location: NE
ADA ID: FD016A1A9E46	Ramp Type: Perp	Initial Pass/Fail: Fail	Overall Compliance: No
Severity Score: 10			
Codes/Mitigation Info/Possible Solution		Field Measurements/Component Compliance

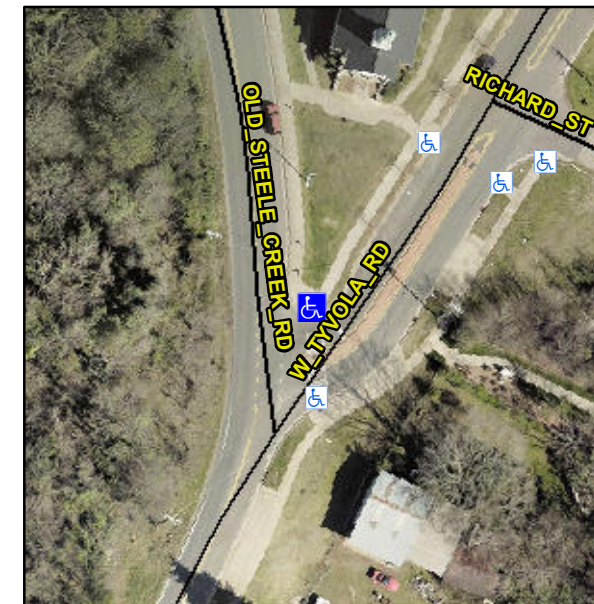
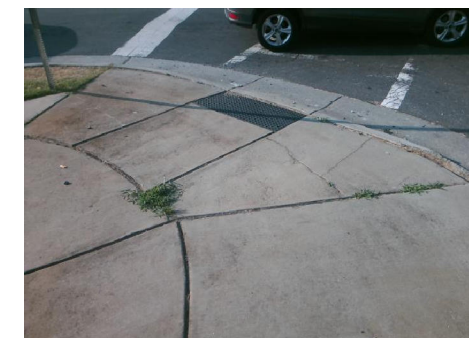
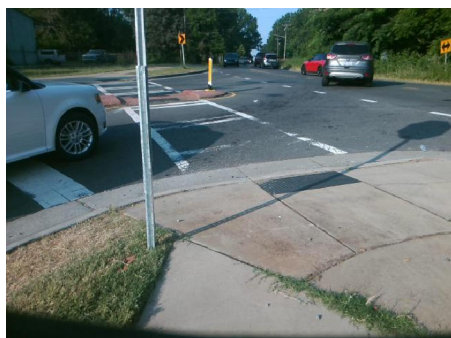
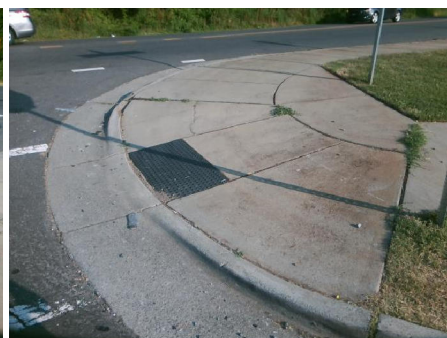
**Not Found, R304.5.1, R304.5.3**

Compliance	Description	Data	Compliance	Description	Data
N/A	Ramp Length (in)	83.0	Yes	Ramp Slope (%)	7.3
No	Ramp Width (in)	43.0	No	Ramp XSlope (%)	4.2
N/A	Flare Type LT	N/A	N/A	Flare Type RT	N/A
N/A	Flare Slope LT (%)	N/A	N/A	Flare Slope RT (%)	N/A
N/A	Flare Traversable LT?	N/A	N/A	Flare Traversable RT?	N/A
N/A	Landing Length (in)	N/A	N/A	DWS Provided?	N/A
N/A	Landing Width (in)	N/A	N/A	DWS Contrast?	N/A
N/A	Landing Slope (%)	N/A	N/A	DWS Length (in)	N/A
N/A	Landing X Slope (%)	N/A	N/A	DWS Full Width?	N/A
N/A	Landing Curb? (Y/N)	N/A	N/A	DWS Offset (in)	N/A
N/A	Shared Landing?	N/A			
N/A	Gutter Ponding?	N/A	N/A	Gutter Slope (%)	N/A
N/A	Gutter Lip Ht (in)	N/A	N/A	Gutter X Slope (%)	N/A
N/A	Painted X Walk1?	Yes	N/A	Painted X Walk2?	N/A
	X Walk 1 Direction	To S		X Walk 2 Direction	N/A
N/A	X Walk 1 Width (in)	93.0	N/A	X Walk 2 Width (in)	N/A
	X Walk 1 Slope (%)	6.6		X Walk 2 Slope (%)	N/A
	X Walk 1 X Slope (%)	4.5		X Walk 2 X Slope (%)	N/A

N/A	Ramp inside XWalk1?	Yes	N/A	Ramp inside XWalk2?	N/A
	Road Slope (%)	N/A	N/A	Clear Space?	N/A
	Road X Slope (%)	N/A	N/A	Clear Space to XWalk (in)	N/A
N/A	Any Obstructions?	N/A	N/A	Storm Grate/Utility Hazard?	N/A
	Obstruction Type			Storm Grate/Utility Type	
		N/A			N/A
		Yes		Surface Condition? (G/P)	Good

**Remove & Replace Entire Ramp.**
