Access Compliance Report

Public Rights-of-Way

(Curb Ramps)

Intersection ID: 11227	Main Street: N_GRAHAM_ST	Cross Street: NC_MUSIC_FACTORY_BV	Location: N
ADA ID: FD06B3B27ED6	Ramp Type: Perp	Initial Pass/Fail: Fail	Overall Compliance: No
		Severity Score: 12.5

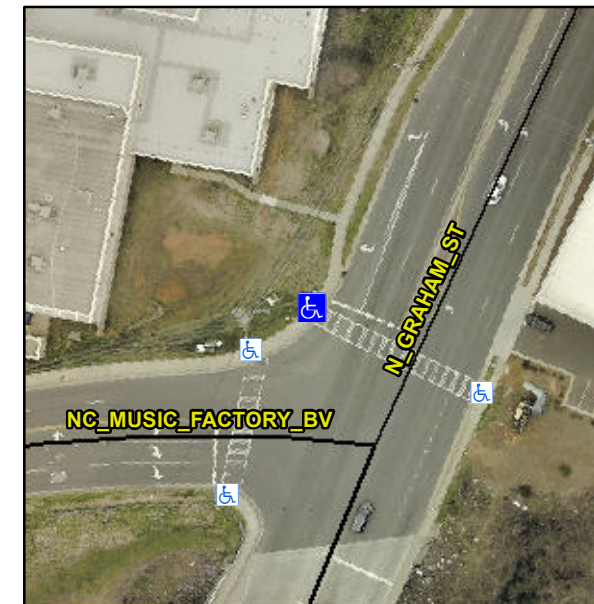
Not Found, R304.2.2

Compliance	Description	Data	Compliance	Description	Data
N/A	Ramp Length (in)	71.5	No	Ramp Slope (%)	8.4
Yes	Ramp Width (in)	48.0	Yes	Ramp XSlope (%)	1.2
N/A	Flare Type LT	N/A	N/A	Flare Type RT	N/A
N/A	Flare Slope LT (%)	N/A	N/A	Flare Slope RT (%)	N/A
N/A	Flare Traversable LT?	N/A	N/A	Flare Traversable RT?	N/A
N/A	Landing Length (in)	N/A	N/A	DWS Provided?	N/A
N/A	Landing Width (in)	N/A	N/A	DWS Contrast?	N/A
N/A	Landing Slope (%)	N/A	N/A	DWS Length (in)	N/A
N/A	Landing X Slope (%)	N/A	N/A	DWS Full Width?	N/A
N/A	Landing Curb? (Y/N)	N/A	N/A	DWS Offset (in)	N/A
N/A	Shared Landing?	N/A			
N/A	Gutter Ponding?	N/A	N/A	Gutter Slope (%)	N/A
N/A	Gutter Lip Ht (in)	N/A	N/A	Gutter X Slope (%)	N/A
N/A	Painted X Walk1?	Yes	N/A	Painted X Walk2?	N/A
	X Walk 1 Direction	To SE		X Walk 2 Direction	N/A
N/A	X Walk 1 Width (in)	113.0	N/A	X Walk 2 Width (in)	N/A
	X Walk 1 Slope (%)	2.1		X Walk 2 Slope (%)	N/A
	X Walk 1 X Slope (%)	1.6		X Walk 2 X Slope (%)	N/A

N/A	Ramp inside XWalk1?	Yes	N/A	Ramp inside XWalk2?	N/A
	Road Slope (%)	N/A	N/A	Clear Space?	N/A
	Road X Slope (%)	N/A	N/A	Clear Space to XWalk (in)	N/A
N/A	Any Obstructions?	N/A	N/A	Storm Grate/Utility Hazard?	N/A
	Obstruction Type			Storm Grate/Utility Type	
		N/A			N/A
			Yes	Surface Condition? (G/P)	Good

Remove & Replace Entire Ramp.
