Access Compliance Report

Public Rights-of-Way

(Curb Ramps)

Intersection ID: 11847	Main Street: E_9TH_ST	Cross Street: N_TRYON_ST	Location: E
ADA ID: FD163419FB0B	Ramp Type: PerpDiag	Initial Pass/Fail: Fail	Overall Compliance: No
Severity Score: 13.75			
Codes/Mitigation Info/Possible Solution		Field Measurements/Component Compliance

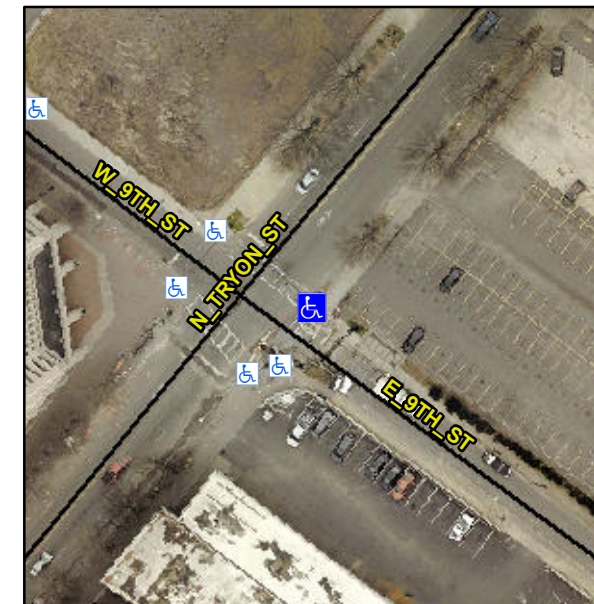
Not Found, R304.2.2, R304.5.3

Compliance	Description	Data	Compliance	Description	Data
N/A	Ramp Length (in)	49.0	No	Ramp Slope (%)	11.0
Yes	Ramp Width (in)	48.0	No	Ramp XSlope (%)	2.1
N/A	Flare Type LT	N/A	N/A	Flare Type RT	N/A
N/A	Flare Slope LT (%)	N/A	N/A	Flare Slope RT (%)	N/A
N/A	Flare Traversable LT?	N/A	N/A	Flare Traversable RT?	N/A
N/A	Landing Length (in)	N/A	N/A	DWS Provided?	N/A
N/A	Landing Width (in)	N/A	N/A	DWS Contrast?	N/A
N/A	Landing Slope (%)	N/A	N/A	DWS Length (in)	N/A
N/A	Landing X Slope (%)	N/A	N/A	DWS Full Width?	N/A
N/A	Landing Curb? (Y/N)	N/A	N/A	DWS Offset (in)	N/A
N/A	Shared Landing?	N/A			
N/A	Gutter Ponding?	N/A	N/A	Gutter Slope (%)	N/A
N/A	Gutter Lip Ht (in)	N/A	N/A	Gutter X Slope (%)	N/A
N/A	Painted X Walk1?	Yes	N/A	Painted X Walk2?	Yes
	X Walk 1 Direction	To NW		X Walk 2 Direction	To SW
N/A	X Walk 1 Width (in)	104.0	N/A	X Walk 2 Width (in)	110.0
	X Walk 1 Slope (%)	6.1		X Walk 2 Slope (%)	5.1
	X Walk 1 X Slope (%)	1.4		X Walk 2 X Slope (%)	3.4

N/A	Ramp inside XWalk1?	Yes	N/A	Ramp inside XWalk2?	Yes
	Road Slope (%)	1.2	N/A	Clear Space?	N/A
	Road X Slope (%)	4.9	N/A	Clear Space to XWalk (in)	N/A
N/A	Any Obstructions?	N/A	N/A	Storm Grate/Utility Hazard?	N/A
	Obstruction Type			Storm Grate/Utility Type	
		N/A			N/A
		Yes		Surface Condition? (G/P)	Good

Remove & Replace Curb Ramp With Two New Directional Ramps or Equivalent.
