Access Compliance Report Public Rights-of-Way (Curb Ramps)

Intersection ID: 31337 Main Street: OLDBRIAR_LN Cross Street: RUSTIC_VIEW_CT Location: E

ADA ID: FD1BE8C6F5ED Ramp Type: BlendTrans2 Initial Pass/Fail: Fail Overall Compliance: No Severity Score: 33.75

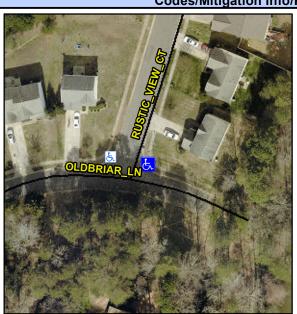
Not Found, R304.5.1, R304.5.3

Compliance Description Data Compliance Description Data Yes BlendTrans Slope (%) N/A Ramp Length (in) 96.0 3.6 No No Ramp Width (in) 45.0 BlendTrans XSlope (%) 9.3 N/A N/A Flare Type LT N/A Flare Type RT N/A N/A Flare Slope LT (%) N/A N/A Flare Slope RT (%) N/A N/A Flare Traversable LT? N/A N/A Flare Traversable RT? N/A N/A Landing Length (in) N/A N/A DWS Provided? N/A N/A Landing Width (in) N/A N/A **DWS Contrast?** N/A N/A N/A N/A Landing Slope (%) DWS Length (in) N/A N/A Landing X Slope (%) N/A N/A DWS Full Width? N/A N/A Landing Curb? (Y/N) N/A N/A DWS Offset (in) N/A N/A N/A Shared Landing? N/A **Gutter Ponding?** N/A N/A Gutter Slope (%) N/A N/A Gutter Lip Ht (in) N/A N/A Gutter X Slope (%) N/A N/A Painted X Walk1? No N/A Painted X Walk2? N/A X Walk 1 Direction To W X Walk 2 Direction N/A N/A X Walk 1 Width (in) X Walk 2 Width (in) N/A X Walk 1 Slope (%) 4.6 X Walk 2 Slope (%) N/A X Walk 1 X Slope (%) 3.0 X Walk 2 X Slope (%) N/A N/A N/A Ramp inside XWalk2? N/A Ramp inside XWalk1? N/A Road Slope (%) 3.0 Clear Space? N/A N/A Road X Slope (%) Clear Space to XWalk (in) N/A 4.6 N/A N/A N/A Any Obstructions? Storm Grate/Utility Hazard? N/A **Obstruction Type** Storm Grate/Utility Type N/A N/A

Remove & Replace Curb Ramp With
Two New Directional Ramps or
Equivalent.

Total Cost: \$ 3200.00
