## Access Compliance Report Public Rights-of-Way (Curb Ramps)

Intersection ID: 31461 Main Street: SENEY\_DR Cross Street: SKIP\_STONE\_DR Location: S

ADA ID: FD1E747729E5 Ramp Type: PerpDiag Initial Pass/Fail: Fail Overall Compliance: No Severity Score: 17.5

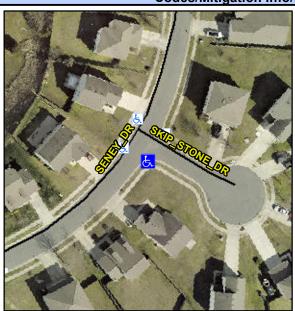
PROW/ADA:
Not Found, R304.5.1

Compliance Description Data Compliance Description Data Yes Ramp Slope (%) N/A Ramp Length (in) 47.5 6.5 Yes Ramp XSlope (%) No Ramp Width (in) 35.0 0.4 N/A N/A Flare Type LT N/A Flare Type RT N/A N/A N/A N/A Flare Slope RT (%) N/A Flare Slope LT (%) N/A Flare Traversable LT? N/A N/A Flare Traversable RT? N/A N/A N/A N/A DWS Provided? N/A Landing Length (in) N/A Landing Width (in) N/A N/A **DWS Contrast?** N/A N/A N/A N/A Landing Slope (%) DWS Length (in) N/A N/A Landing X Slope (%) N/A N/A DWS Full Width? N/A N/A Landing Curb? (Y/N) N/A N/A DWS Offset (in) N/A N/A N/A Shared Landing? N/A **Gutter Ponding?** N/A N/A Gutter Slope (%) N/A N/A Gutter Lip Ht (in) N/A N/A Gutter X Slope (%) N/A N/A Painted X Walk1? No N/A Painted X Walk2? No X Walk 1 Direction To NE X Walk 2 Direction To NW N/A N/A X Walk 1 Width (in) X Walk 2 Width (in) N/A X Walk 1 Slope (%) 1.9 X Walk 2 Slope (%) 2.1 X Walk 1 X Slope (%) 1.8 X Walk 2 X Slope (%) 1.4 N/A N/A N/A Ramp inside XWalk2? N/A Ramp inside XWalk1? Road Slope (%) 0.5 N/A Clear Space? N/A N/A Road X Slope (%) Clear Space to XWalk (in) N/A 1.6

SKIP STONE DR StopSign SENEY DR None Possible Solutions:

Remove & Replace Curb Ramp With
Two New Directional Ramps or
Equivalent.

Total Cost: \$ 3200.00
