# Access Compliance Report

## Public Rights-of-Way

### (Curb Ramps)

| Intersection ID: 16273 | Main Street: HARTFORD_AV | Cross Street: MAYFIELD_AV | Location: | N |

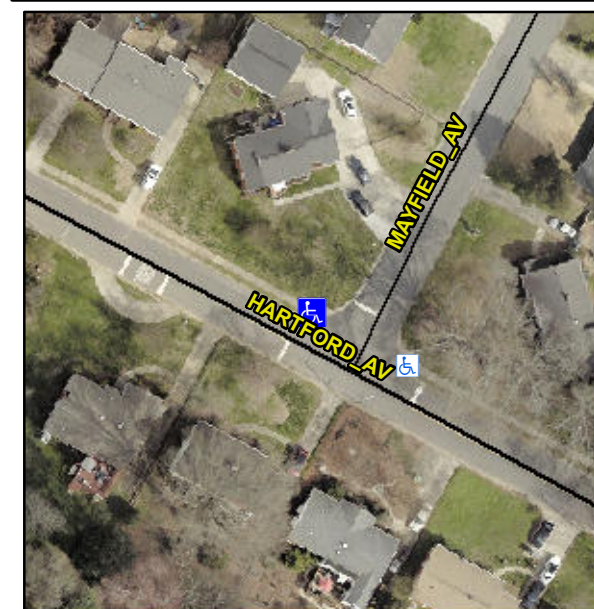
| ADA ID: FD2FD848D0F1 | Ramp Type: PerpDiag | Initial Pass/Fail: Pass | Overall Compliance: No | Severity Score: 10 |

**Not Found, R304.2.1, R304.2.2-Perp, R304.3.2-Para, R304.5.3, R305.2**

| Compliance | Description | Data | Compliance | Description | Data |
|---|---|---|---|---|---|
| No | Landing Length (in) | N/A | Yes | DWS Provided? | Yes |
| No | Landing Width (in) | N/A | Yes | DWS Contrast? | Yes |
| No | Landing Slope (%) | N/A | Yes | DWS Length (in) | 24.0 |
| No | Landing X Slope (%) | N/A | Yes | DWS Full Width? | Yes |
| N/A | Landing Curb? (Y/N) | No | No | DWS Offset (in) | 3.0 |

**Remove & Replace Curb Ramp With Two New Directional Ramps or Equivalent.**
