Access Compliance Report Public Rights-of-Way (Curb Ramps)

Intersection ID: 21739
 Main Street:
 IMPERIAL_CT
 Cross Street:
 ENGLAND_ST
 Location:
 SW

ADA ID: FD3D196A1EE5
 Ramp Type:
 PerpDiag
 Initial Pass/Fail:
 Pass
 Overall Compliance:
 No
 Severity Score:
 20.25

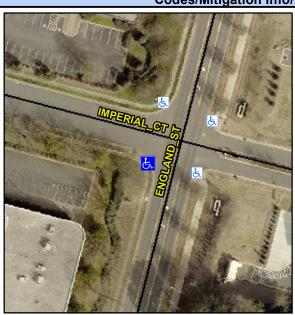
N/A

| Field Measurements/Component Compliance | | | | | |
|---|---|---|---|---|---|
| Yes | Ramp Width (in) | 48.0 | No | Ramp XSlope (%) | 2.9 |
| No | Landing Length (in) | N/A | No | DWS Provided? | No |
| No | Landing Width (in) | N/A | N/A | DWS Contrast? | No |
| No | Landing Slope (%) | N/A | N/A | DWS Length (in) | N/A |
| No | Landing X Slope (%) | N/A | N/A | DWS Full Width? | No |

Remove & Replace Curb Ramp With Two New Directional Ramps or Equivalent.

R304.5.3, R304.2.1, R304.2.2-Perp, R304.3.2-Para, R305

Total Cost: \$ 3200.00
