Access Compliance Report

Public Rights-of-Way

(Curb Ramps)

Intersection ID: 14249	Main Street: E_3RD_ST	Cross Street: QUEENS_RD	Location: SE
ADA ID: FD4CADFCBE73	Ramp Type: PerpDiag	Initial Pass/Fail: Fail	Overall Compliance: No
Severity Score: 12.5			
Codes/Mitigation Info/Possible Solution		Field Measurements/Component Compliance

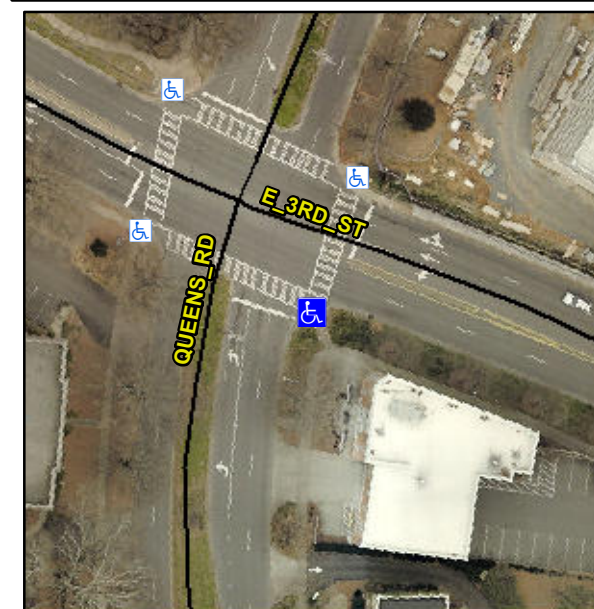
Compliance	Description	Data	Compliance	Description	Data
N/A	Ramp Length (in)	72.5	No	Ramp Slope (%)	10.7
Yes	Ramp Width (in)	49.0	Yes	Ramp XSlope (%)	0.1
N/A	Flare Type LT	N/A	N/A	Flare Type RT	N/A
N/A	Flare Slope LT (%)	N/A	N/A	Flare Slope RT (%)	N/A
N/A	Flare Traversable LT?	N/A	N/A	Flare Traversable RT?	N/A
N/A	Landing Length (in)	N/A	N/A	DWS Provided?	N/A
N/A	Landing Width (in)	N/A	N/A	DWS Contrast?	N/A
N/A	Landing Slope (%)	N/A	N/A	DWS Length (in)	N/A
N/A	Landing X Slope (%)	N/A	N/A	DWS Full Width?	N/A
N/A	Landing Curb? (Y/N)	N/A	N/A	DWS Offset (in)	N/A
N/A	Shared Landing?	N/A			
N/A	Gutter Ponding?	N/A	N/A	Gutter Slope (%)	N/A
N/A	Gutter Lip Ht (in)	N/A	N/A	Gutter X Slope (%)	N/A
N/A	Painted X Walk1?	Yes	N/A	Painted X Walk2?	Yes
	X Walk 1 Direction	To NE		X Walk 2 Direction	To NW
N/A	X Walk 1 Width (in)	114.0	N/A	X Walk 2 Width (in)	113.0
	X Walk 1 Slope (%)	6.3		X Walk 2 Slope (%)	3.1
	X Walk 1 X Slope (%)	1.9		X Walk 2 X Slope (%)	4.2

N/A	Ramp inside XWalk1?	Yes	N/A	Ramp inside XWalk2?	Yes
	Road Slope (%)	1.0	N/A	Clear Space?	N/A
	Road X Slope (%)	5.4	N/A	Clear Space to XWalk (in)	N/A
N/A	Any Obstructions?	N/A	N/A	Storm Grate/Utility Hazard?	N/A
	Obstruction Type			Storm Grate/Utility Type	
		N/A			N/A
		Yes		Surface Condition? (G/P)	Good

Possible Solutions:

Remove & Replace Curb Ramp With Two New Directional Ramps or Equivalent.

R304.2.2
