Access Compliance Report

Public Rights-of-Way

(Curb Ramps)

Intersection ID: 3253	Main Street: SUTTONVIEW_DR	Cross Street: SHADOW_PINE_DR	Location: NE
ADA ID: FD559739C8A7	Ramp Type: Perp	Initial Pass/Fail: Pass	Overall Compliance: No
		Severity Score: 5.25

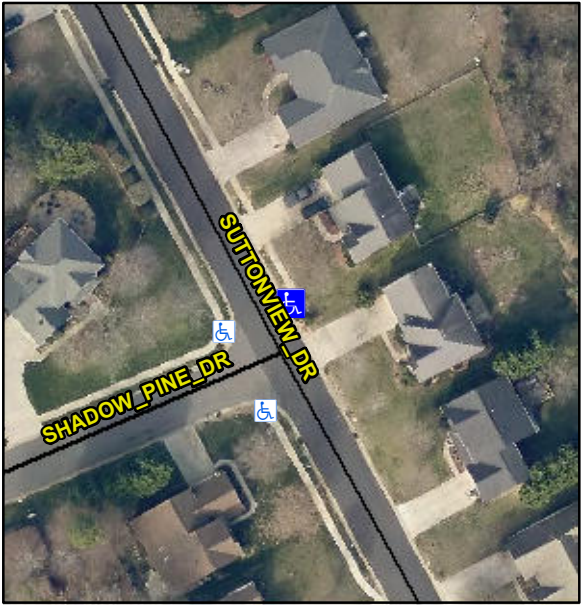
Possible Solutions:		Compliance	Description	Data
	Remove & Replace Entire Ramp.		Yes	Ramp Length (in)	48.5
			Yes	Ramp Width (in)	48.0
			N/A	Flare Type LT	Sloped
			N/A	Flare Slope LT (%)	3.7
			N/A	Flare Traversable LT?	Yes
			Yes	Landing Length (in)	48.0
			Yes	Landing Width (in)	48.0
			Yes	Landing Slope (%)	0.8
			No	Landing X Slope (%)	4.5
			N/A	Landing Curb? (Y/N)	No
			N/A	Shared Landing?	No
			Yes	Gutter Ponding?	No
			Yes	Gutter Lip Ht (in)	0.0
			N/A	Painted X Walk1?	No
				X Walk 1 Direction	To W
			N/A	X Walk 1 Width (in)	N/A
				X Walk 1 Slope (%)	5.7
				X Walk 1 X Slope (%)	4.0
			N/A	Ramp inside XWalk1?	N/A
<p>Surveyor Notes:</p> <p>N/A</p> <p>PROW/ADA:</p> <p>R304.5.3, R304.2.3</p>			N/A	Flare Type RT	N/A
			No	Flare Slope RT (%)	12.9
			N/A	Flare Traversable RT?	Yes
			Yes	DWS Provided?	Yes
			Yes	DWS Contrast?	Yes

Yes	DWS Length (in)	25.5
			Yes	DWS Full Width?	Yes
			Yes	DWS Offset (in)	2.0
			Yes	Gutter Slope (%)	3.6
			Yes	Gutter X Slope (%)	3.9
			N/A	Painted X Walk2?	N/A
				X Walk 2 Direction	N/A
			N/A	X Walk 2 Width (in)	N/A
				X Walk 2 Slope (%)	N/A
				X Walk 2 X Slope (%)	N/A
			N/A	Ramp inside XWalk2?	N/A
			N/A	Clear Space?	Yes
			N/A	Clear Space to XWalk (in)	N/A
			Yes	Storm Grate/Utility Hazard?	No
<p>Total Cost:</p> <p>\$ 1850.00</p>				Storm Grate/Utility Type	
			N/A		N/A
			Yes	Surface Condition? (G/P)	Good
