Access Compliance Report

Public Rights-of-Way

(Curb Ramps)

Intersection ID: 14305	Main Street: CLEVELAND_AV	Cross Street: E WORTHINGTON AV	Location:	N
ADA ID: FD56469809D4	Ramp Type: Directional1	Initial Pass/Fail: Fail	Overall Compliance: No	Severity Score: 10
Codes/Mitigation Info/Possible Solution		Field Measurements/Component Compliance

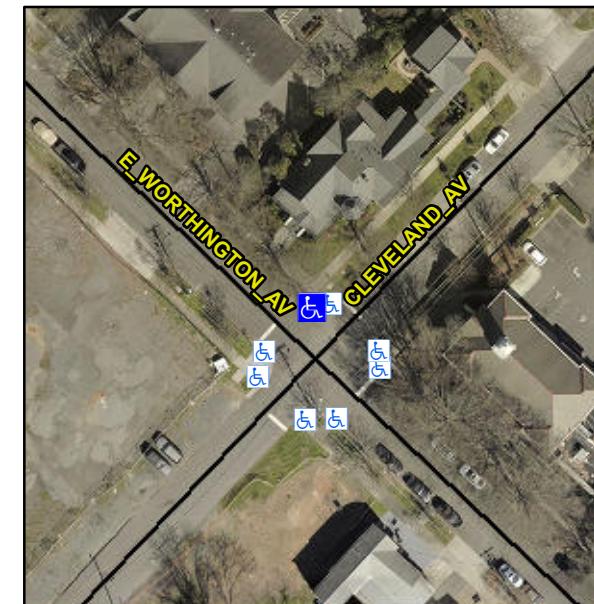
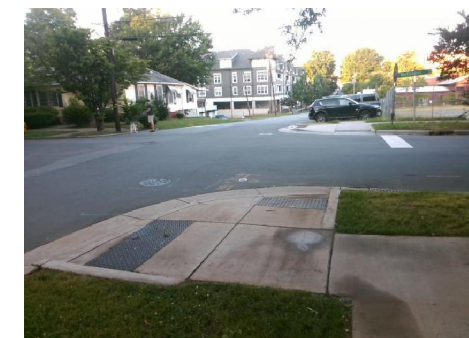
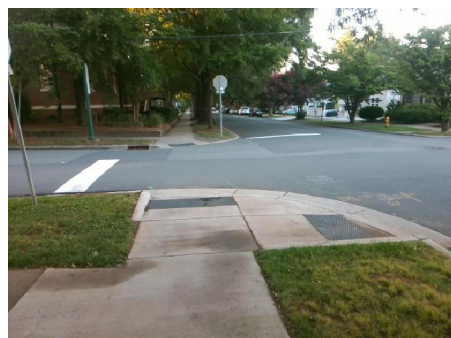
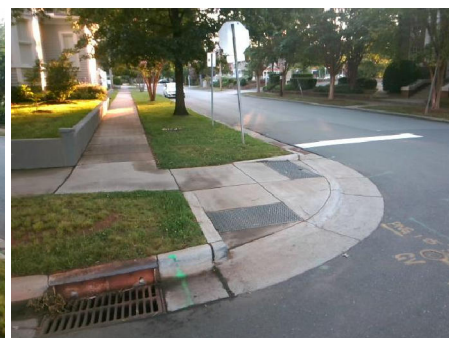
R304.5.1, R304.5.3

Compliance	Description	Data	Compliance	Description	Data
N/A	Ramp Length (in)	62.0	N/A	Grade Break?	N/A
No	Ramp Width (in)	44.0	N/A	Grade Break Slope (%)	0.0
Yes	Ramp Slope (%)	6.7	N/A	Grade Break XSlope (%)	0.0
No	Ramp XSlope (%)	2.1			
N/A	Flare Type LT	N/A	N/A	Flare Type RT	N/A
N/A	Flare Slope LT (%)	N/A	N/A	Flare Slope RT (%)	0.0
N/A	Flare Traversable LT?	N/A	N/A	Flare Traversable RT?	N/A
N/A	Landing Length (in)	0.0	N/A	DWS Provided?	N/A
N/A	Landing Width (in)	0.0	N/A	DWS Contrast?	N/A
N/A	Landing Slope (%)	0.0	N/A	DWS Length (in)	N/A
N/A	Landing X Slope (%)	0.0	N/A	DWS Full Width?	N/A
N/A	Landing Curb? (Y/N)	N/A	N/A	DWS Offset LT (in)	N/A
N/A	Shared Landing?	N/A	N/A	DWS Offset RT (in)	N/A
N/A	Gutter Ponding?	0.0	N/A	Gutter Slope (%)	N/A
N/A	Gutter Lip Ht (in)	0.0	N/A	Gutter X Slope (%)	N/A
N/A	Painted X Walk1?	No		Road Slope (%)	5.9
	X Walk 1 Direction	To SW		Road X Slope (%)	1.5
	X Walk 1 Width (in)	N/A		Clear Space?	N/A

X Walk 1 Slope (%)	5.9	N/A	Clear Space to XWalk (in)	N/A
	X Walk 1 X Slope (%)	1.5	N/A	Storm Grate/Utility Hazard?	N/A
N/A	Ramp inside XWalk1?	N/A		Storm Grate/Utility Type	
N/A	Any Obstructions?	N/A			N/A
	Obstruction Type		Yes	Surface Condition? (G/P)	Good
			N/A	Curb Slope (%)	17.8

Remove & Replace Entire Ramp.
