Access Compliance Report

Public Rights-of-Way

(Curb Ramps)

Intersection ID: 6714	Main Street: NEVIN_RD	Cross Street: LAKE_RD	Location: SW
ADA ID: FD6E183F182B	Ramp Type: PerpDiag	Initial Pass/Fail: Fail	Overall Compliance: No
Codes/Mitigation Info/Possible Solution		Field Measurements/Component Compliance	
Severity Score: 10

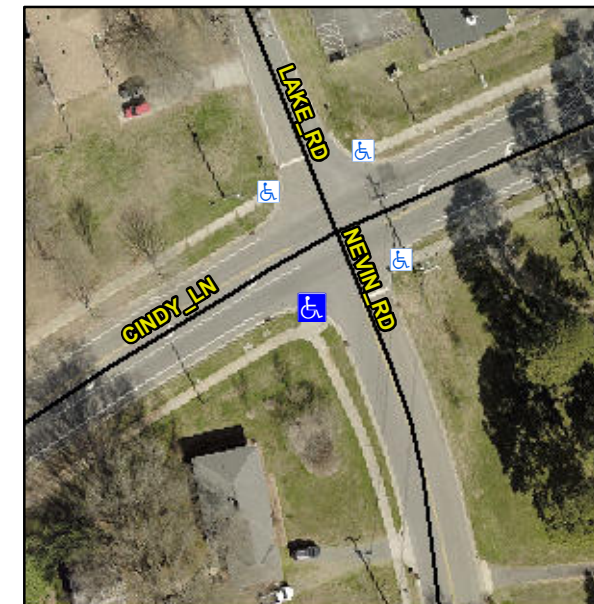
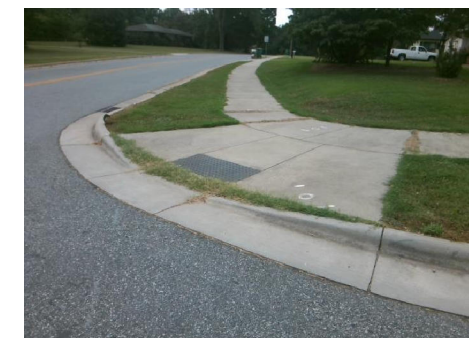
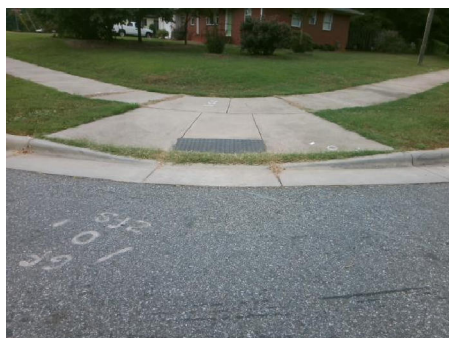
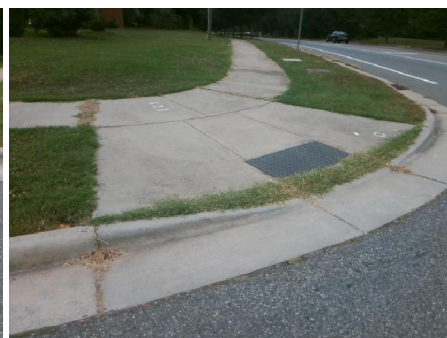
Compliance	Description	Data	Compliance	Description	Data
N/A	Ramp Length (in)	95.0	Yes	Ramp Slope (%)	6.6
No	Ramp Width (in)	36.0	No	Ramp XSlope (%)	3.3
N/A	Flare Type LT	N/A	N/A	Flare Type RT	N/A
N/A	Flare Slope LT (%)	N/A	N/A	Flare Slope RT (%)	N/A
N/A	Flare Traversable LT?	N/A	N/A	Flare Traversable RT?	N/A
N/A	Landing Length (in)	N/A	N/A	DWS Provided?	N/A
N/A	Landing Width (in)	N/A	N/A	DWS Contrast?	N/A
N/A	Landing Slope (%)	N/A	N/A	DWS Length (in)	N/A
N/A	Landing X Slope (%)	N/A	N/A	DWS Full Width?	N/A
N/A	Landing Curb? (Y/N)	N/A	N/A	DWS Offset (in)	N/A
N/A	Shared Landing?	N/A			
N/A	Gutter Ponding?	N/A	N/A	Gutter Slope (%)	N/A
N/A	Gutter Lip Ht (in)	N/A	N/A	Gutter X Slope (%)	N/A
N/A	Painted X Walk1?	No	N/A	Painted X Walk2?	No
	X Walk 1 Direction	To E		X Walk 2 Direction	To N
N/A	X Walk 1 Width (in)	N/A	N/A	X Walk 2 Width (in)	N/A
	X Walk 1 Slope (%)	1.9		X Walk 2 Slope (%)	0.5
	X Walk 1 X Slope (%)	1.4		X Walk 2 X Slope (%)	3.2

N/A	Ramp inside XWalk1?	N/A	N/A	Ramp inside XWalk2?	N/A
	Road Slope (%)	3.8	N/A	Clear Space?	N/A
	Road X Slope (%)	0.7	N/A	Clear Space to XWalk (in)	N/A
N/A	Any Obstructions?	N/A	N/A	Storm Grate/Utility Hazard?	N/A
	Obstruction Type			Storm Grate/Utility Type	
		N/A			N/A
			Yes	Surface Condition? (G/P)	Good

Remove & Replace Curb Ramp With Two New Directional Ramps or Equivalent.
