Access Compliance Report

Public Rights-of-Way

(Curb Ramps)

Intersection ID: 51704	Main Street: IKEA_BV	Cross Street: BROOKSIDE_LN	Location: NE
ADA ID: FD6F70112D17	Ramp Type: Perp	Initial Pass/Fail: Pass	Overall Compliance: No
		Severity Score: 0

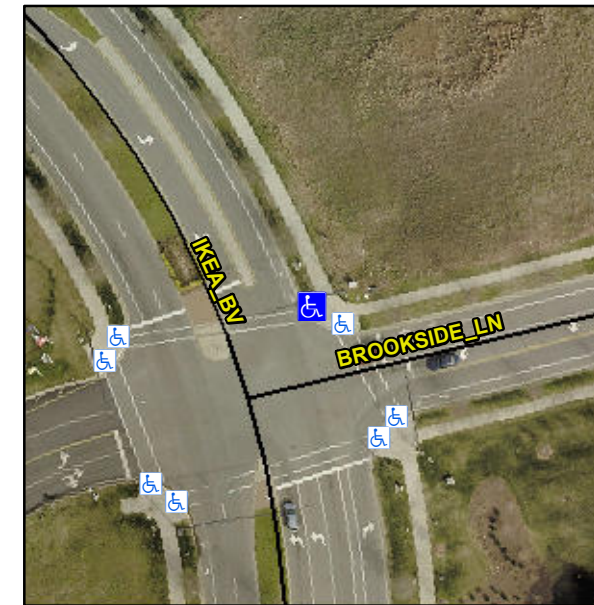
Compliance	Description	Data	Compliance	Description	Data
N/A	Ramp Length (in)	96.0	Yes	Ramp Slope (%)	6.1
Yes	Ramp Width (in)	48.0	Yes	Ramp XSlope (%)	1.2
N/A	Flare Type LT	Sloped	N/A	Flare Type RT	N/A
N/A	Flare Slope LT (%)	7.4	Yes	Flare Slope RT (%)	5.9
N/A	Flare Traversable LT?	No	N/A	Flare Traversable RT?	Yes
Yes	Landing Length (in)	90.0	Yes	DWS Provided?	Yes
Yes	Landing Width (in)	48.0	Yes	DWS Contrast?	Yes
No	Landing Slope (%)	2.8	Yes	DWS Length (in)	24.5
Yes	Landing X Slope (%)	1.6	Yes	DWS Full Width?	Yes
N/A	Landing Curb? (Y/N)	No	No	DWS Offset (in)	4.0
N/A	Shared Landing?	No			
Yes	Gutter Ponding?	No	Yes	Gutter Slope (%)	1.8
Yes	Gutter Lip Ht (in)	0.0	Yes	Gutter X Slope (%)	0.4
N/A	Painted X Walk1?	Yes	N/A	Painted X Walk2?	N/A
	X Walk 1 Direction	To W		X Walk 2 Direction	N/A
N/A	X Walk 1 Width (in)	61.0	N/A	X Walk 2 Width (in)	N/A
	X Walk 1 Slope (%)	2.5		X Walk 2 Slope (%)	N/A
	X Walk 1 X Slope (%)	0.1		X Walk 2 X Slope (%)	N/A

Yes	Ramp inside XWalk1?	Yes	N/A	Ramp inside XWalk2?	N/A
	Road Slope (%)	N/A	N/A	Clear Space?	Yes
	Road X Slope (%)	N/A	N/A	Clear Space to XWalk (in)	N/A
Yes	Any Obstructions?	No	Yes	Storm Grate/Utility Hazard?	No
	Obstruction Type			Storm Grate/Utility Type	
		N/A			N/A
			Yes	Surface Condition? (G/P)	Good

Possible Solutions:

Remove & Replace Entire Ramp.
