Access Compliance Report

Public Rights-of-Way

(Curb Ramps)

Intersection ID: 48475	Main Street: SHALLOW_OAK_CT	Cross Street: AUTUMN_OAK_DR	Location: W
ADA ID: FD7B04023E9C	Ramp Type: PerpDiag	Initial Pass/Fail: Fail	Overall Compliance: No
Severity Score: 73.75			
Codes/Mitigation Info/Possible Solution		Field Measurements/Component Compliance

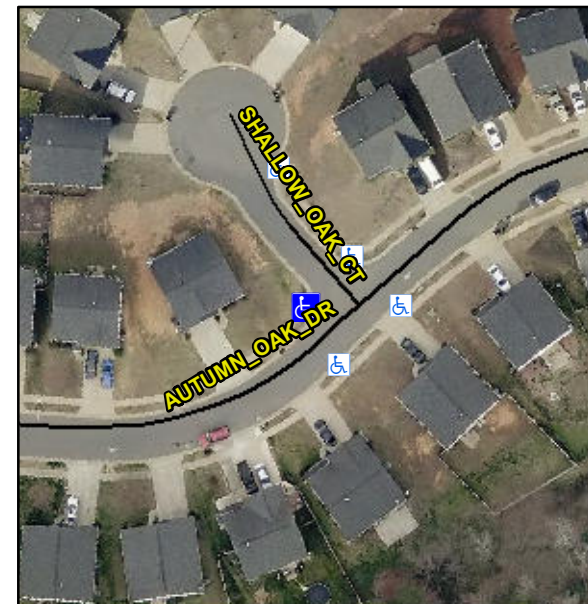
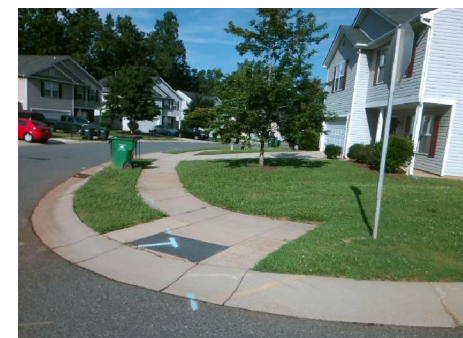
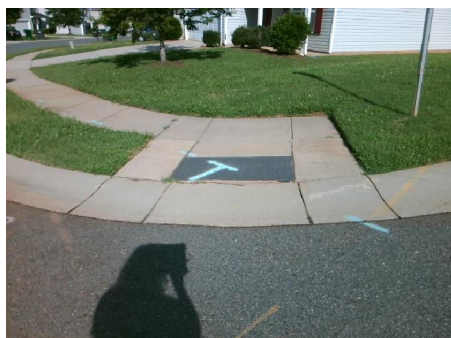
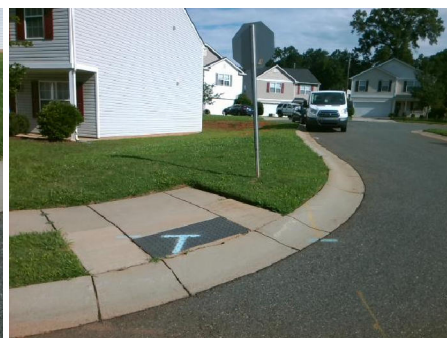
Not Found, R304.5.1, R304.2.2, R304.5.3, R302.7

Compliance	Description	Data	Compliance	Description	Data
N/A	Ramp Length (in)	49.5	No	Ramp Slope (%)	17.0
No	Ramp Width (in)	46.5	No	Ramp XSlope (%)	7.6
N/A	Flare Type LT	N/A	N/A	Flare Type RT	N/A
N/A	Flare Slope LT (%)	N/A	N/A	Flare Slope RT (%)	N/A
N/A	Flare Traversable LT?	N/A	N/A	Flare Traversable RT?	N/A
N/A	Landing Length (in)	N/A	N/A	DWS Provided?	N/A
N/A	Landing Width (in)	N/A	N/A	DWS Contrast?	N/A
N/A	Landing Slope (%)	N/A	N/A	DWS Length (in)	N/A
N/A	Landing X Slope (%)	N/A	N/A	DWS Full Width?	N/A
N/A	Landing Curb? (Y/N)	N/A	N/A	DWS Offset (in)	N/A
N/A	Shared Landing?	N/A			
N/A	Gutter Ponding?	N/A	N/A	Gutter Slope (%)	N/A
N/A	Gutter Lip Ht (in)	N/A	N/A	Gutter X Slope (%)	N/A
N/A	Painted X Walk1?	No	N/A	Painted X Walk2?	No
	X Walk 1 Direction	To SE		X Walk 2 Direction	To NE
N/A	X Walk 1 Width (in)	N/A	N/A	X Walk 2 Width (in)	N/A
	X Walk 1 Slope (%)	1.1		X Walk 2 Slope (%)	5.2
	X Walk 1 X Slope (%)	4.2		X Walk 2 X Slope (%)	4.6

N/A	Ramp inside XWalk1?	N/A	N/A	Ramp inside XWalk2?	N/A
	Road Slope (%)	6.0	N/A	Clear Space?	N/A
	Road X Slope (%)	1.7	N/A	Clear Space to XWalk (in)	N/A
N/A	Any Obstructions?	N/A	N/A	Storm Grate/Utility Hazard?	N/A
	Obstruction Type			Storm Grate/Utility Type	
		N/A			N/A
		No		Surface Condition? (G/P)	Poor

Remove & Replace Curb Ramp With Two New Directional Ramps or Equivalent.
