# Access Compliance Report

## Public Rights-of-Way

### (Curb Ramps)

| Intersection ID: 49690 | Main Street: ALEXANDRA_ALLEY_DR | Cross Street: SHARON_HILLS_RD | Location: E |

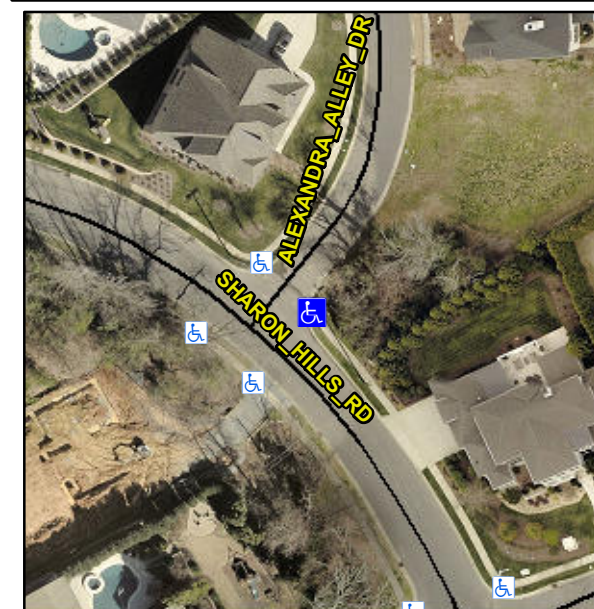
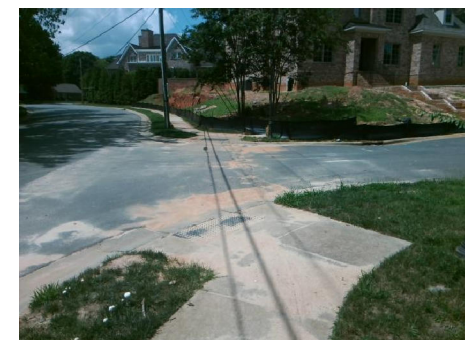
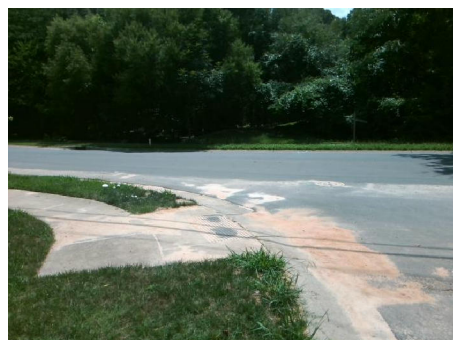
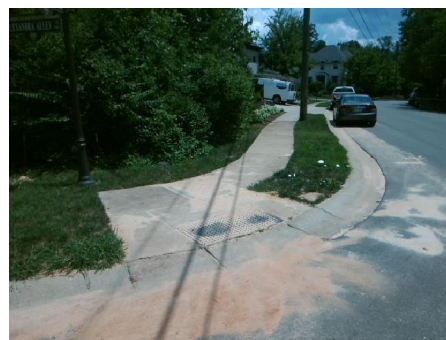
| ADA ID: FD7FDE7D1CA6 | Ramp Type: BlendTrans1 | Initial Pass/Fail: Pass | Overall Compliance: No |

| Severity Score: 5.25 | | | |

**Not Found, R304.5.3, R304.2.1, R302.7, R304.5.4**

| Compliance | Description | Data | Compliance | Description | Data |
|---|---|---|---|---|---|
| No | Landing Length (in) | 46.0 | Yes | DWS Provided? | Yes |
| No | Landing X Slope (%) | 2.7 | Yes | DWS Full Width? | Yes |
| No | Gutter Ponding? | Yes | No | Gutter Slope (%) | 8.0 |

**Remove & Replace Curb Ramp With Two New Directional Ramps or Equivalent. Remove & Replace Gutter.**

Total Cost: \$ 3950.00
