Access Compliance Report Public Rights-of-Way (Curb Ramps)

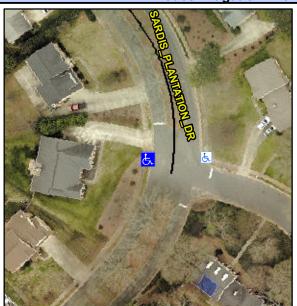
Possible Solutions:	2
Remove & Replace Entire Ramp.	1
	١
	ı
	ı
	ı
	ı
Surveyor Notes:	ı
N/A	ı
	ı
	ı
	ı
PROW/ADA:	ı
Not Found, R304.2.2, R304.5.3	ľ
	ı
	_
	ı
	ı

Codes/Mitigation Info/Possible Solution
