Access Compliance Report Public Rights-of-Way (Curb Ramps)

Intersection ID: 12788 Main Street: NASSAU_BV Cross Street: SPRAGUE_AV Location: SE Ramp Type: Directional1 **Overall Compliance: No** ADA ID: FD8D8D6A9861 Initial Pass/Fail: Fail Severity Score: 26.25

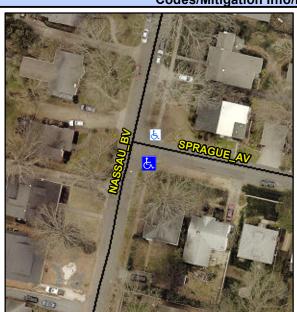
Compliance Description Data Compliance Description Data Compliance Description					
N/A	Ramp Length (in)	91.5	N/A	Grade Break?	N/A
Yes	Ramp Width (in)	53.0	N/A	Grade Break Slope (%)	0.0
No	Ramp Slope (%)	17.5	N/A	Grade Break XSlope (%)	0.0
Yes	Ramp XSlope (%)	2.5			
N/A	Flare Type LT	N/A	N/A	Flare Type RT	N/A
N/A	Flare Slope LT (%)	N/A	N/A	Flare Slope RT (%)	0.0
N/A	Flare Traversable LT?	N/A	N/A	Flare Traversable RT?	N/A
N/A	Landing Length (in)	0.0	N/A	DWS Provided?	N/A
N/A	Landing Width (in)	0.0	N/A	DWS Contrast?	N/A
N/A	Landing Slope (%)	0.0	N/A	DWS Length (in)	N/A
N/A	Landing X Slope (%)	0.0	N/A	DWS Full Width?	N/A
N/A	Landing Curb? (Y/N)	N/A	N/A	DWS Offset LT (in)	N/A
N/A	Shared Landing?	N/A	N/A	DWS Offset RT (in)	N/A
N/A	Gutter Ponding?	0.0	N/A	Gutter Slope (%)	N/A
N/A	Gutter Lip Ht (in)	0.0	N/A	Gutter X Slope (%)	N/A
N/A	Painted X Walk1?	No		Road Slope (%)	4.2
	X Walk 1 Direction	To N		Road X Slope (%)	5.7

X Walk 1 Width (in)	N/A		Clear Space?	N/A
	X Walk 1 Slope (%)	4.2	N/A	Clear Space to XWalk (in)	N/A
	X Walk 1 X Slope (%)	5.7	N/A	Storm Grate/Utility Hazard?	N/A
N/A	Ramp inside XWalk1?	N/A		Storm Grate/Utility Type	
N/A	Any Obstructions?	N/A			N/A
	Obstruction Type		Yes	Surface Condition? (G/P)	Good
		N/A	N/A	Curb Slope (%)	27.5
	Obstruction Type	N/A		,	•

Possible Solutions:
Remove & Replace Entire Ramp.
Surveyor Notes:
N/A
PROW/ADA:
R304.2.2
