Access Compliance Report

Public Rights-of-Way

(Curb Ramps)

Intersection ID: N/A	Main Street: PINEVILLE-MATTHEWS_RD	Cross Street: COURTSIDE_LN	Location: N
ADA ID: FD936402609D	Ramp Type: Perp	Initial Pass/Fail: Fail	Overall Compliance: No
Codes/Mitigation Info/Possible Solution		Field Measurements/Component Compliance	
Severity Score: 12.5

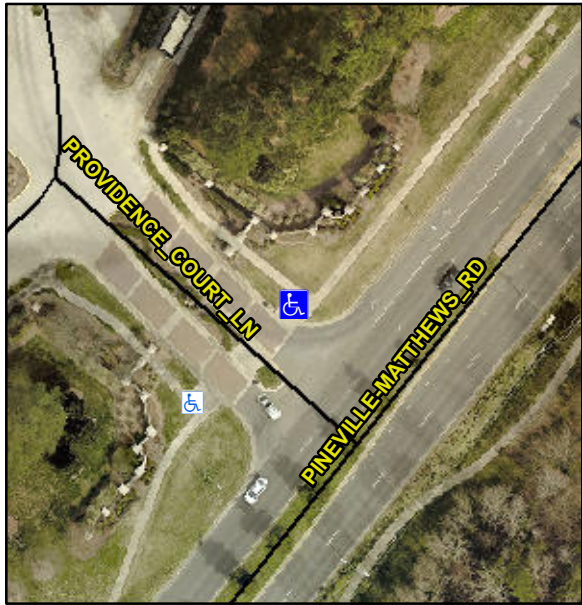
Compliance	Description	Data	Compliance	Description	Data
N/A	Ramp Length (in)	130.0	Yes	Ramp Slope (%)	5.4
Yes	Ramp Width (in)	65.0	No	Ramp XSlope (%)	6.3
N/A	Flare Type LT	N/A	N/A	Flare Type RT	N/A
N/A	Flare Slope LT (%)	N/A	N/A	Flare Slope RT (%)	N/A
N/A	Flare Traversable LT?	N/A	N/A	Flare Traversable RT?	N/A
N/A	Landing Length (in)	N/A	N/A	DWS Provided?	N/A
N/A	Landing Width (in)	N/A	N/A	DWS Contrast?	N/A
N/A	Landing Slope (%)	N/A	N/A	DWS Length (in)	N/A
N/A	Landing X Slope (%)	N/A	N/A	DWS Full Width?	N/A
N/A	Landing Curb? (Y/N)	N/A	N/A	DWS Offset (in)	N/A
N/A	Shared Landing?	N/A			
N/A	Gutter Ponding?	N/A	N/A	Gutter Slope (%)	N/A
N/A	Gutter Lip Ht (in)	N/A	N/A	Gutter X Slope (%)	N/A
N/A	Painted X Walk1?	No	N/A	Painted X Walk2?	N/A
	X Walk 1 Direction	To SW		X Walk 2 Direction	N/A
N/A	X Walk 1 Width (in)	N/A	N/A	X Walk 2 Width (in)	N/A
	X Walk 1 Slope (%)	1.0		X Walk 2 Slope (%)	N/A
	X Walk 1 X Slope (%)	3.6		X Walk 2 X Slope (%)	N/A

N/A	Ramp inside XWalk1?	N/A	N/A	Ramp inside XWalk2?	N/A
	Road Slope (%)	N/A	N/A	Clear Space?	N/A
	Road X Slope (%)	N/A	N/A	Clear Space to XWalk (in)	N/A
N/A	Any Obstructions?	N/A	N/A	Storm Grate/Utility Hazard?	N/A
	Obstruction Type			Storm Grate/Utility Type	
		N/A			N/A
			Yes	Surface Condition? (G/P)	Good

Possible Solutions:

Remove & Replace Entire Ramp.

PROW/ADA:

R304.5.3

Total Cost:\$1850.00
