Access Compliance Report

Public Rights-of-Way

(Curb Ramps)

Intersection ID: 2846	Main Street: BEITH_CT	Cross Street: TAYMOUTH_LN	Location: NE
ADA ID: FDB28F233829	Ramp Type: BlendTrans1	Initial Pass/Fail: Fail	Overall Compliance: No
		Severity Score: 12.5

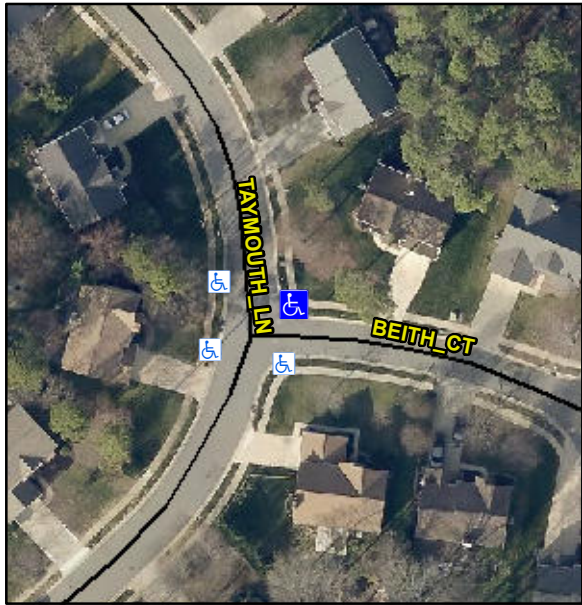
Possible Solutions:		Compliance	Description	Data	Compliance	Description	Data
	Remove & Replace Curb Ramp With Two New Directional Ramps or Equivalent.		N/A	Ramp Length (in)	52.0	Yes	BlendTrans Slope (%)	4.4
			Yes	Ramp Width (in)	132.0	No	BlendTrans XSlope (%)	5.5
			N/A	Flare Type LT	N/A	N/A	Flare Type RT	N/A
			N/A	Flare Slope LT (%)	N/A	N/A	Flare Slope RT (%)	N/A
			N/A	Flare Traversable LT?	N/A	N/A	Flare Traversable RT?	N/A
			N/A	Landing Length (in)	N/A	N/A	DWS Provided?	N/A
			N/A	Landing Width (in)	N/A	N/A	DWS Contrast?	N/A
			N/A	Landing Slope (%)	N/A	N/A	DWS Length (in)	N/A
			N/A	Landing X Slope (%)	N/A	N/A	DWS Full Width?	N/A
			N/A	Landing Curb? (Y/N)	N/A	N/A	DWS Offset (in)	N/A
			N/A	Shared Landing?	N/A			
			N/A	Gutter Ponding?	N/A	N/A	Gutter Slope (%)	N/A
			N/A	Gutter Lip Ht (in)	N/A	N/A	Gutter X Slope (%)	N/A

N/A	Painted X Walk1?	No	N/A	Painted X Walk2?	No
				X Walk 1 Direction	To W		X Walk 2 Direction	To S
				X Walk 1 Width (in)	N/A		X Walk 2 Width (in)	N/A
				X Walk 1 Slope (%)	6.6		X Walk 2 Slope (%)	1.5
				X Walk 1 X Slope (%)	0.0		X Walk 2 X Slope (%)	4.3
			N/A	Ramp inside XWalk1?	N/A	N/A	Ramp inside XWalk2?	N/A
			Road Slope (%)	3.8		Clear Space?	N/A	
			Road X Slope (%)	4.2	N/A	Clear Space to XWalk (in)	N/A	
		N/A	Any Obstructions?	N/A	N/A	Storm Grate/Utility Hazard?	N/A	
			Obstruction Type			Storm Grate/Utility Type		
					N/A		N/A	
					Yes	Surface Condition? (G/P)	Good	
					No	Curb Slope (%)	19.0
