Access Compliance Report

Public Rights-of-Way

(Curb Ramps)

Intersection ID: 42533	Main Street: CASTLETOWN_HOUSE_DR	Cross Street: ROTHE_HOUSE_RD	Location: W
ADA ID: FDB416544738	Ramp Type: PerpDiag	Initial Pass/Fail: Fail	Overall Compliance: No
		Severity Score: 22.5

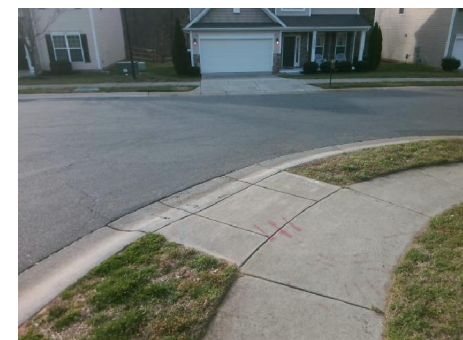
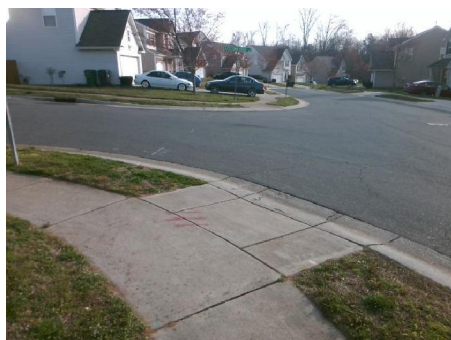
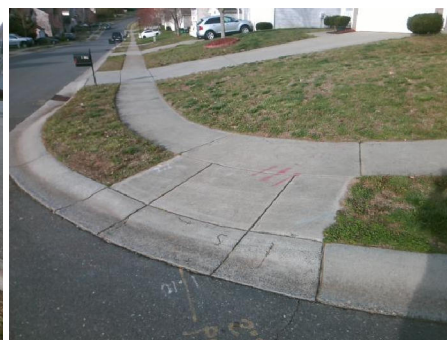
R304.5.1, R304.2.2, R304.5.3

Compliance	Description	Data	Compliance	Description	Data
N/A	Ramp Length (in)	44.5	No	Ramp Slope (%)	10.2
No	Ramp Width (in)	43.5	No	Ramp XSlope (%)	4.0
N/A	Flare Type LT	N/A	N/A	Flare Type RT	N/A
N/A	Flare Slope LT (%)	N/A	N/A	Flare Slope RT (%)	N/A
N/A	Flare Traversable LT?	N/A	N/A	Flare Traversable RT?	N/A
N/A	Landing Length (in)	N/A	N/A	DWS Provided?	N/A
N/A	Landing Width (in)	N/A	N/A	DWS Contrast?	N/A
N/A	Landing Slope (%)	N/A	N/A	DWS Length (in)	N/A
N/A	Landing X Slope (%)	N/A	N/A	DWS Full Width?	N/A
N/A	Landing Curb? (Y/N)	N/A	N/A	DWS Offset (in)	N/A
N/A	Shared Landing?	N/A			
N/A	Gutter Ponding?	N/A	N/A	Gutter Slope (%)	N/A
N/A	Gutter Lip Ht (in)	N/A	N/A	Gutter X Slope (%)	N/A
N/A	Painted X Walk1?	No	N/A	Painted X Walk2?	No
	X Walk 1 Direction	To SE		X Walk 2 Direction	To NE
N/A	X Walk 1 Width (in)	N/A	N/A	X Walk 2 Width (in)	N/A
	X Walk 1 Slope (%)	2.7		X Walk 2 Slope (%)	0.8
	X Walk 1 X Slope (%)	0.6		X Walk 2 X Slope (%)	4.2

N/A	Ramp inside XWalk1?	N/A	N/A	Ramp inside XWalk2?	N/A
	Road Slope (%)	3.3	N/A	Clear Space?	N/A
	Road X Slope (%)	2.1	N/A	Clear Space to XWalk (in)	N/A
N/A	Any Obstructions?	N/A	N/A	Storm Grate/Utility Hazard?	N/A
	Obstruction Type			Storm Grate/Utility Type	
		N/A			N/A
			Yes	Surface Condition? (G/P)	Good

Remove & Replace Curb Ramp With Two New Directional Ramps or Equivalent.
