## **Access Compliance Report Public Rights-of-Way** (Curb Ramps)

Intersection ID: 10025745 Main Street: EBBETS\_RD Cross Street: N/A Location: N **Overall Compliance: No** ADA ID: FDBB4DE520C9 Ramp Type: Perp Initial Pass/Fail: Fail **Severity Score:** 10

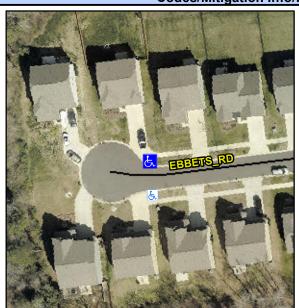
Possible Solution	Field Measurements/Component Compliance					
Possible Solutions:	Compl	iance Description	Data	Complian	ce Description	Data
Remove & Replace Entire Ramp.	N/A	Ramp Length (in)	96.0	Yes R	amp Slope (%)	5.8
	No	Ramp Width (in)	42.0	Yes R	amp XSlope (%)	3.5
	N/A	Flare Type LT	N/A	<b>N/A</b> FI	are Type RT	N/A
	N/A	Flare Slope LT (%)	N/A	<b>N/A</b> FI	are Slope RT (%)	N/A
	N/A	Flare Traversable LT?	N/A	<b>N/A</b> FI	are Traversable RT?	N/A
	N/A	Landing Length (in)	N/A	N/A D	WS Provided?	N/A
Surveyor Notes:	N/A	Landing Width (in)	N/A	N/A D	WS Contrast?	N/A
N/A	N/A	Landing Slope (%)	N/A	N/A D	WS Length (in)	N/A
	N/A	Landing X Slope (%)	N/A	N/A D	WS Full Width?	N/A
	N/A	Landing Curb? (Y/N)	N/A	<b>N/A</b> D	WS Offset (in)	N/A
	N/A	Shared Landing?	N/A			
PROW/ADA:	N/A	Gutter Ponding?	N/A	<b>N/A</b> G	utter Slope (%)	N/A
Not Found, R304.5.1	N/A	Gutter Lip Ht (in)	N/A	<b>N/A</b> G	utter X Slope (%)	N/A

N/A	Painted X Walk1?	No	N/A P	ainted X Walk2?	N/A
		X Walk 1 Direction	To S	Х	Walk 2 Direction	N/A
	N/A	X Walk 1 Width (in)	N/A	N/A X	Walk 2 Width (in)	N/A
		X Walk 1 Slope (%)	2.6	Х	Walk 2 Slope (%)	N/A
		X Walk 1 X Slope (%)	4.1	Х	Walk 2 X Slope (%)	N/A
	N/A	Ramp inside XWalk1?	N/A	N/A R	amp inside XWalk2?	N/A
		Road Slope (%)	N/A	N/A C	lear Space?	N/A
		Road X Slope (%)	N/A	N/A C	lear Space to XWalk (in)	N/A
	N/A	Any Obstructions?	N/A	N/A S	torm Grate/Utility Hazard?	N/A
Total Cost: \$ 1850.00		Obstruction Type		St	torm Grate/Utility Type	
			N/A			N/A
				Yes S	urface Condition? (G/P)	Good
