Access Compliance Report

Public Rights-of-Way

(Curb Ramps)

Intersection ID: 14741		Main Street: EAST_BV		Cross Street: PARK_RD		Location: NE											
ADA ID: FDBC3241D33F		Ramp Type: Directional1		Initial Pass/Fail: Fail		Overall Compliance: No		Severity Score: 12.5									
Codes/Mitigation Info/Possible Solution				Field Measurements/Component Compliance													
<div>

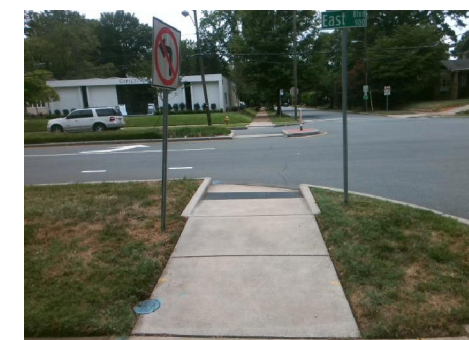
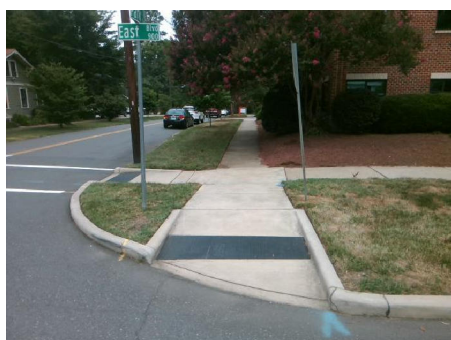
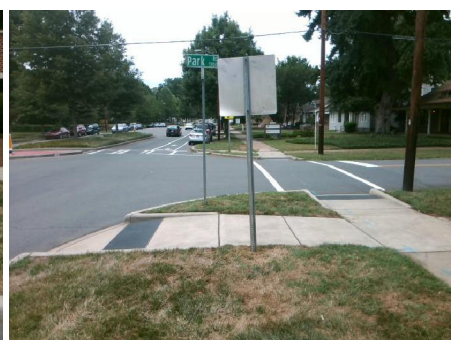
No		Ramp Slope (%)		8.8		N/A		Grade Break XSlope (%)		0.0			
				Yes		Ramp XSlope (%)		1.0									
				N/A		Flare Type LT		N/A		N/A		Flare Type RT		N/A			
				N/A		Flare Slope LT (%)		N/A		N/A		Flare Slope RT (%)		0.0			
				N/A		Flare Traversable LT?		N/A		N/A		Flare Traversable RT?		N/A			
				N/A		Landing Length (in)		0.0		N/A		DWS Provided?		N/A			
				N/A		Landing Width (in)		0.0		N/A		DWS Contrast?		N/A			
				N/A		Landing Slope (%)		0.0		N/A		DWS Length (in)		N/A			
				N/A		Landing X Slope (%)		0.0		N/A		DWS Full Width?		N/A			
				N/A		Landing Curb? (Y/N)		N/A		N/A		DWS Offset LT (in)		N/A			
				N/A		Shared Landing?		N/A		N/A		DWS Offset RT (in)		N/A			
				N/A		Gutter Ponding?		0.0		N/A		Gutter Slope (%)		N/A			
				N/A		Gutter Lip Ht (in)		0.0		N/A		Gutter X Slope (%)		N/A			
				N/A		Painted X Walk1?		No				Road Slope (%)		3.8			
						X Walk 1 Direction		To SW				Road X Slope (%)		0.2

X Walk 1 Width (in)		N/A				Clear Space?		N/A			
						X Walk 1 Slope (%)		3.8		N/A		Clear Space to XWalk (in)		N/A			
						X Walk 1 X Slope (%)		0.2		N/A		Storm Grate/Utility Hazard?		N/A			
				N/A		Ramp inside XWalk1?		N/A				Storm Grate/Utility Type					
				N/A		Any Obstructions?		N/A						N/A			
						Obstruction Type				Yes		Surface Condition? (G/P)		Good			
										N/A		N/A		Curb Slope (%)		4.2
