Intersection ID: 10033044	Main Street: NOLLEY_CT	Cross Street: N/A	Location:	N
ADA ID: FDBFF3EB680D	Ramp Type: BlendTrans1	Initial Pass/Fail: Fail	Overall Compliance: No	Severity Score: 8.75

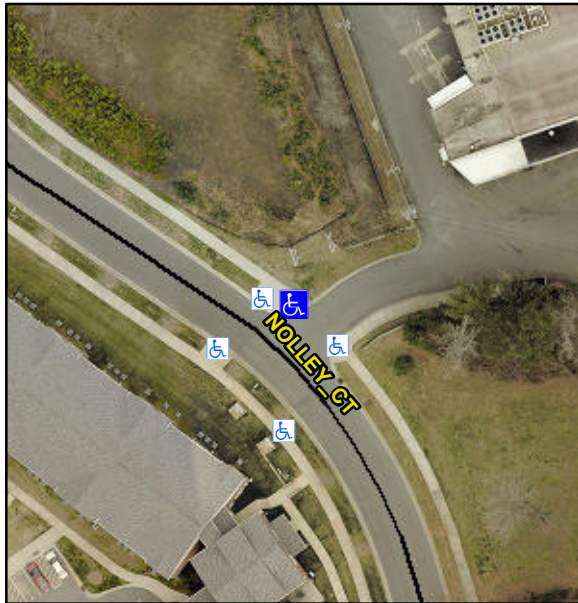
Not Found, R304.5.1

Compliance	Description	Data	Compliance	Description	Data
N/A	Ramp Length (in)	67.0	Yes	BlendTrans Slope (%)	1.9
No	Ramp Width (in)	47.0	Yes	BlendTrans XSlope (%)	0.6
N/A	Flare Type LT	N/A	N/A	Flare Type RT	N/A
N/A	Flare Slope LT (%)	N/A	N/A	Flare Slope RT (%)	N/A
N/A	Flare Traversable LT?	N/A	N/A	Flare Traversable RT?	N/A
N/A	Landing Length (in)	N/A	N/A	DWS Provided?	N/A
N/A	Landing Width (in)	N/A	N/A	DWS Contrast?	N/A
N/A	Landing Slope (%)	N/A	N/A	DWS Length (in)	N/A
N/A	Landing X Slope (%)	N/A	N/A	DWS Full Width?	N/A
N/A	Landing Curb? (Y/N)	N/A	N/A	DWS Offset (in)	N/A
N/A	Shared Landing?	N/A			
N/A	Gutter Ponding?	N/A	N/A	Gutter Slope (%)	N/A
N/A	Gutter Lip Ht (in)	N/A	N/A	Gutter X Slope (%)	N/A
N/A	Painted X Walk1?	No	N/A	Painted X Walk2?	N/A
	X Walk 1 Direction	To SE		X Walk 2 Direction	N/A
	X Walk 1 Width (in)	N/A		X Walk 2 Width (in)	N/A
	X Walk 1 Slope (%)	3.3		X Walk 2 Slope (%)	N/A
	X Walk 1 X Slope (%)	1.0		X Walk 2 X Slope (%)	N/A

N/A	Ramp inside XWalk1?	N/A	N/A	Ramp inside XWalk2?	N/A
	Road Slope (%)	1.0		Clear Space?	N/A
	Road X Slope (%)	3.3	N/A	Clear Space to XWalk (in)	N/A
N/A	Any Obstructions?	N/A	N/A	Storm Grate/Utility Hazard?	N/A
	Obstruction Type			Storm Grate/Utility Type	
		N/A			N/A
			Yes	Surface Condition? (G/P)	Good
			No	Curb Slope (%)	17.6

Remove & Replace Curb Ramp With Two New Directional Ramps or Equivalent.

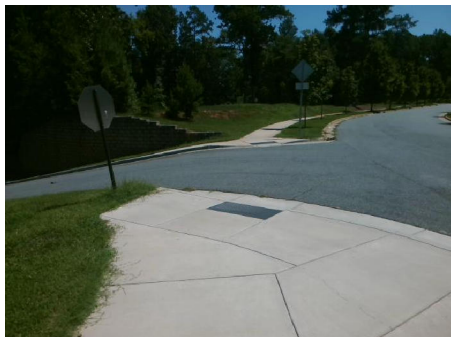
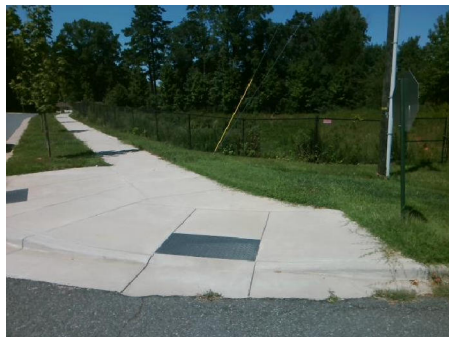
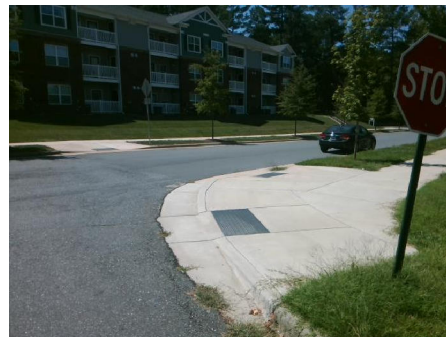
Street 1 Name	ENTRANCE
Stop Condition-Street 1	StopSign
Street 2 Name	N/A
Stop Condition-Street 2	N/A
