# Access Compliance Report

## Public Rights-of-Way

### (Curb Ramps)

Intersection ID: 10772	Main Street: E_36TH_ST	Cross Street: THE_PLAZA	Location: SW
ADA ID: FDC520140DEA	Ramp Type: Perp	Initial Pass/Fail: Fail	Overall Compliance: No
Severity Score: 8.75			
Codes/Mitigation Info/Possible Solution		Field Measurements/Component Compliance

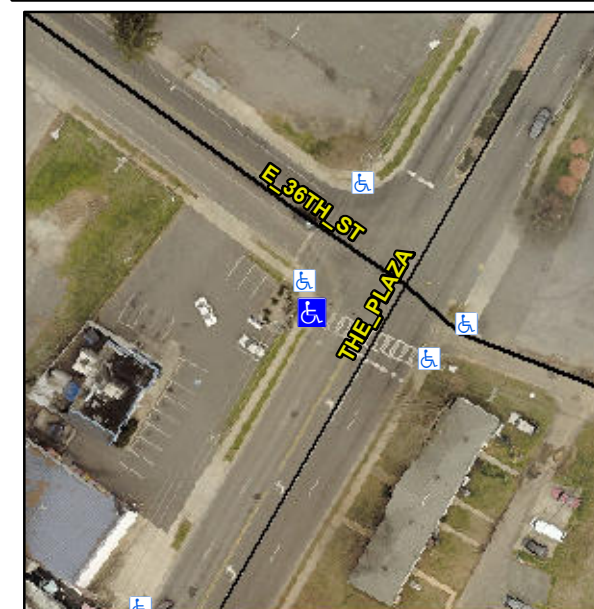
**Not Found, R304.5.1**

Compliance	Description	Data	Compliance	Description	Data
N/A	Ramp Length (in)	36.0	Yes	Ramp Slope (%)	6.9
No	Ramp Width (in)	41.5	Yes	Ramp XSlope (%)	0.9
N/A	Flare Type LT	N/A	N/A	Flare Type RT	N/A
N/A	Flare Slope LT (%)	N/A	N/A	Flare Slope RT (%)	N/A
N/A	Flare Traversable LT?	N/A	N/A	Flare Traversable RT?	N/A
N/A	Landing Length (in)	N/A	N/A	DWS Provided?	N/A
N/A	Landing Width (in)	N/A	N/A	DWS Contrast?	N/A
N/A	Landing Slope (%)	N/A	N/A	DWS Length (in)	N/A
N/A	Landing X Slope (%)	N/A	N/A	DWS Full Width?	N/A
N/A	Landing Curb? (Y/N)	N/A	N/A	DWS Offset (in)	N/A
N/A	Shared Landing?	N/A			
N/A	Gutter Ponding?	N/A	N/A	Gutter Slope (%)	N/A
N/A	Gutter Lip Ht (in)	N/A	N/A	Gutter X Slope (%)	N/A
N/A	Painted X Walk1?	Yes	N/A	Painted X Walk2?	N/A
	X Walk 1 Direction	To SE		X Walk 2 Direction	N/A
N/A	X Walk 1 Width (in)	111.5	N/A	X Walk 2 Width (in)	N/A
	X Walk 1 Slope (%)	2.9		X Walk 2 Slope (%)	N/A
	X Walk 1 X Slope (%)	0.9		X Walk 2 X Slope (%)	N/A

N/A	Ramp inside XWalk1?	Yes	N/A	Ramp inside XWalk2?	N/A
	Road Slope (%)	N/A	N/A	Clear Space?	N/A
	Road X Slope (%)	N/A	N/A	Clear Space to XWalk (in)	N/A
N/A	Any Obstructions?	N/A	N/A	Storm Grate/Utility Hazard?	N/A
	Obstruction Type			Storm Grate/Utility Type	
		N/A			N/A
			Yes	Surface Condition? (G/P)	Good

Possible Solutions:

**Remove & Replace Entire Ramp.**
