Access Compliance Report

Public Rights-of-Way

(Curb Ramps)

Intersection ID: 53624	Main Street: PROSPERITY RIDGE RD	Cross Street: RIDGE RD	Location: SW
ADA ID: FDC5691EA704	Ramp Type: Perp	Initial Pass/Fail: Fail	Overall Compliance: No
Severity Score: 33.75			
Codes/Mitigation Info/Possible Solution		Field Measurements/Component Compliance

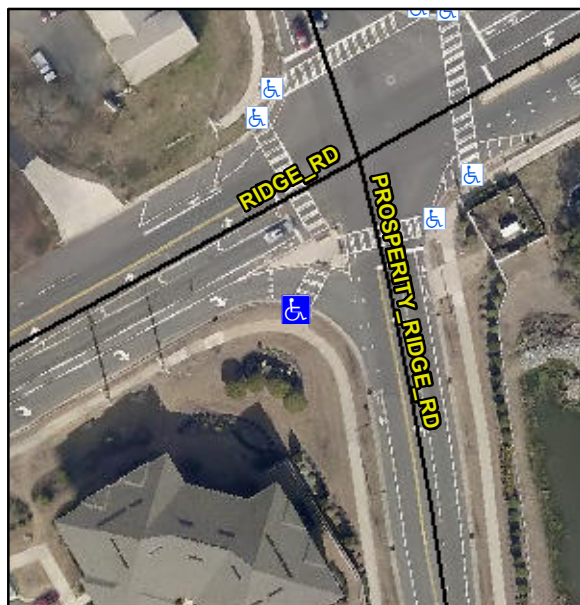
Compliance	Description	Data	Compliance	Description	Data
N/A	Ramp Length (in)	96.0	No	Ramp Slope (%)	8.8
No	Ramp Width (in)	47.5	No	Ramp XSlope (%)	5.1
N/A	Flare Type LT	N/A	N/A	Flare Type RT	N/A
N/A	Flare Slope LT (%)	N/A	N/A	Flare Slope RT (%)	N/A
N/A	Flare Traversable LT?	N/A	N/A	Flare Traversable RT?	N/A
N/A	Landing Length (in)	N/A	N/A	DWS Provided?	N/A
N/A	Landing Width (in)	N/A	N/A	DWS Contrast?	N/A
N/A	Landing Slope (%)	N/A	N/A	DWS Length (in)	N/A
N/A	Landing X Slope (%)	N/A	N/A	DWS Full Width?	N/A
N/A	Landing Curb? (Y/N)	N/A	N/A	DWS Offset (in)	N/A
N/A	Shared Landing?	N/A			
N/A	Gutter Ponding?	N/A	N/A	Gutter Slope (%)	N/A
N/A	Gutter Lip Ht (in)	N/A	N/A	Gutter X Slope (%)	N/A
N/A	Painted X Walk1?	Yes	N/A	Painted X Walk2?	N/A
	X Walk 1 Direction	To NE		X Walk 2 Direction	N/A
N/A	X Walk 1 Width (in)	113.0	N/A	X Walk 2 Width (in)	N/A
	X Walk 1 Slope (%)	3.0		X Walk 2 Slope (%)	N/A
	X Walk 1 X Slope (%)	2.9		X Walk 2 X Slope (%)	N/A

N/A	Ramp inside XWalk1?	Yes	N/A	Ramp inside XWalk2?	N/A
	Road Slope (%)	N/A	N/A	Clear Space?	N/A
	Road X Slope (%)	N/A	N/A	Clear Space to XWalk (in)	N/A
N/A	Any Obstructions?	N/A	N/A	Storm Grate/Utility Hazard?	N/A
	Obstruction Type			Storm Grate/Utility Type	
		N/A			N/A
			Yes	Surface Condition? (G/P)	Good

Possible Solutions:

Remove & Replace Entire Ramp.

R304.5.1, R304.2.2, R304.5.3
