Access Compliance Report

Public Rights-of-Way

(Curb Ramps)

Intersection ID: 17062	Main Street: IDLEWILD_RD	Cross Street: MONROE_RD	Location: NW
ADA ID: FDD0030EFCC6	Ramp Type: MedianPerp	Initial Pass/Fail: Fail	Overall Compliance: No
Severity Score: 13.75			
Codes/Mitigation Info/Possible Solution		Field Measurements/Component Compliance

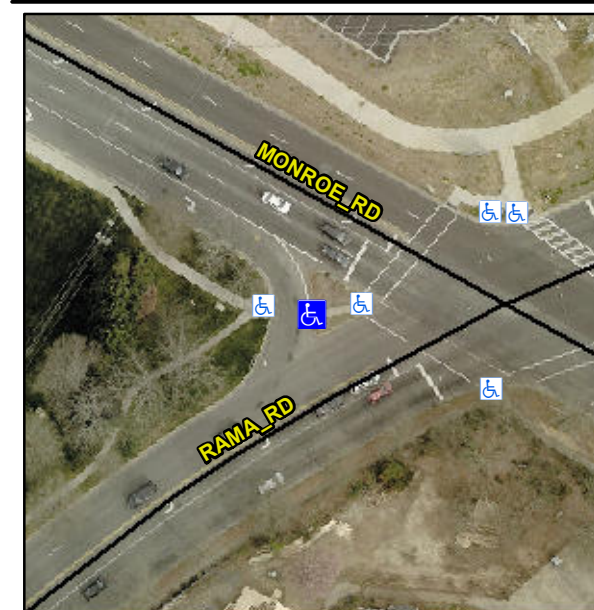
Not Found, R304.2.2, R304.5.3

Compliance	Description	Data	Compliance	Description	Data
N/A	Ramp Length (in)	56.0	No	Ramp Slope (%)	11.9
Yes	Ramp Width (in)	48.0	No	Ramp XSlope (%)	2.2
N/A	Flare Type LT	N/A	N/A	Flare Type RT	N/A
N/A	Flare Slope LT (%)	N/A	N/A	Flare Slope RT (%)	N/A
N/A	Flare Traversable LT?	N/A	N/A	Flare Traversable RT?	N/A
N/A	Landing Length (in)	N/A	N/A	DWS Provided?	N/A
N/A	Landing Width (in)	N/A	N/A	DWS Contrast?	N/A
N/A	Landing Slope (%)	N/A	N/A	DWS Length (in)	N/A
N/A	Landing X Slope (%)	N/A	N/A	DWS Full Width?	N/A
N/A	Landing Curb? (Y/N)	N/A	N/A	DWS Offset (in)	N/A
N/A	Shared Landing?	N/A			
N/A	Gutter Ponding?	N/A	N/A	Gutter Slope (%)	N/A
N/A	Gutter Lip Ht (in)	N/A	N/A	Gutter X Slope (%)	N/A
N/A	Painted X Walk1?	Yes	N/A	Painted X Walk2?	N/A
	X Walk 1 Direction	To NW		X Walk 2 Direction	N/A
N/A	X Walk 1 Width (in)	112.0	N/A	X Walk 2 Width (in)	N/A
	X Walk 1 Slope (%)	1.3		X Walk 2 Slope (%)	N/A
	X Walk 1 X Slope (%)	3.8		X Walk 2 X Slope (%)	N/A

N/A	Ramp inside XWalk1?	Yes	N/A	Ramp inside XWalk2?	N/A
	Road Slope (%)	N/A	N/A	Clear Space?	N/A
	Road X Slope (%)	N/A	N/A	Clear Space to XWalk (in)	N/A
N/A	Any Obstructions?	N/A	N/A	Storm Grate/Utility Hazard?	N/A
	Obstruction Type			Storm Grate/Utility Type	
		N/A			N/A
			Yes	Surface Condition? (G/P)	Good

Possible Solutions:

Remove & Replace Entire Ramp.
