Access Compliance Report

Public Rights-of-Way

(Curb Ramps)

Intersection ID: 23117	Main Street: CEDAR_CROSSINGS_DR	Cross Street: ERWIN_RD	Location: E
ADA ID: FDD8410FB0DC	Ramp Type: PerpDiag	Initial Pass/Fail: Fail	Overall Compliance: No
		Severity Score: 25

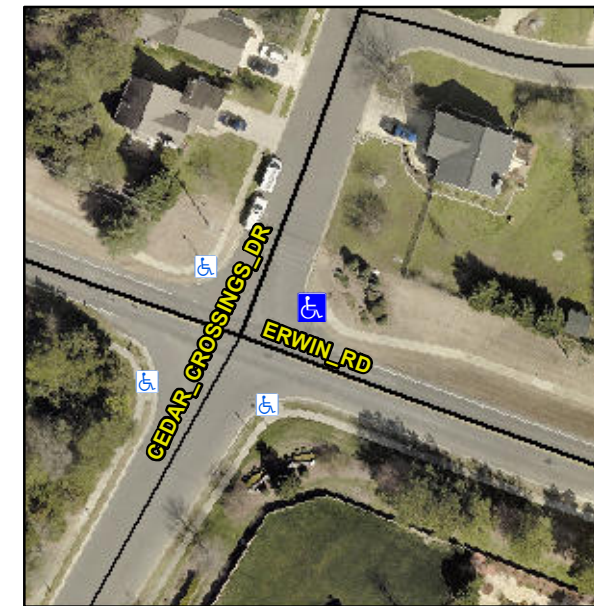
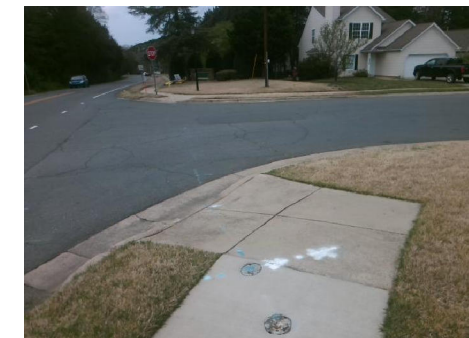
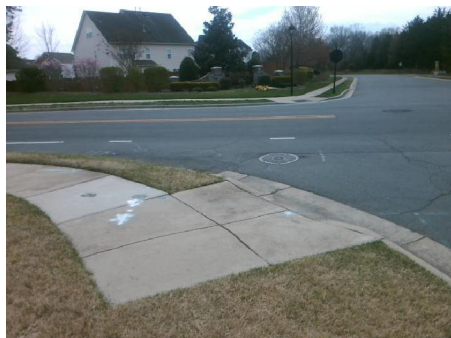
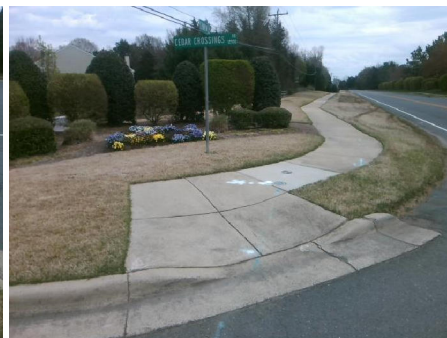
Compliance	Description	Data	Compliance	Description	Data
N/A	Ramp Length (in)	111.0	No	Ramp Slope (%)	12.7
Yes	Ramp Width (in)	48.0	Yes	Ramp XSlope (%)	0.1
N/A	Flare Type LT	N/A	N/A	Flare Type RT	N/A
N/A	Flare Slope LT (%)	N/A	N/A	Flare Slope RT (%)	N/A
N/A	Flare Traversable LT?	N/A	N/A	Flare Traversable RT?	N/A
N/A	Landing Length (in)	N/A	N/A	DWS Provided?	N/A
N/A	Landing Width (in)	N/A	N/A	DWS Contrast?	N/A
N/A	Landing Slope (%)	N/A	N/A	DWS Length (in)	N/A
N/A	Landing X Slope (%)	N/A	N/A	DWS Full Width?	N/A
N/A	Landing Curb? (Y/N)	N/A	N/A	DWS Offset (in)	N/A
N/A	Shared Landing?	N/A			
N/A	Gutter Ponding?	N/A	N/A	Gutter Slope (%)	N/A
N/A	Gutter Lip Ht (in)	N/A	N/A	Gutter X Slope (%)	N/A
N/A	Painted X Walk1?	No	N/A	Painted X Walk2?	No
	X Walk 1 Direction	To NW		X Walk 2 Direction	To SW
N/A	X Walk 1 Width (in)	N/A	N/A	X Walk 2 Width (in)	N/A
	X Walk 1 Slope (%)	2.2		X Walk 2 Slope (%)	1.2
	X Walk 1 X Slope (%)	2.5		X Walk 2 X Slope (%)	0.4

N/A	Ramp inside XWalk1?	N/A	N/A	Ramp inside XWalk2?	N/A
	Road Slope (%)	1.9	N/A	Clear Space?	N/A
	Road X Slope (%)	1.0	N/A	Clear Space to XWalk (in)	N/A
N/A	Any Obstructions?	N/A	N/A	Storm Grate/Utility Hazard?	N/A
	Obstruction Type			Storm Grate/Utility Type	
		N/A			N/A
			Yes	Surface Condition? (G/P)	Good

Remove & Replace Curb Ramp With Two New Directional Ramps or Equivalent.
