Access Compliance Report

Public Rights-of-Way

(Curb Ramps)

Intersection ID: 10017628	Main Street: TIMBER_RIDGE_RD	Cross Street: N/A	Location: W
ADA ID: FDE0F2E10E68	Ramp Type: Perp	Initial Pass/Fail: Pass	Overall Compliance: No
			Severity Score: 10.25

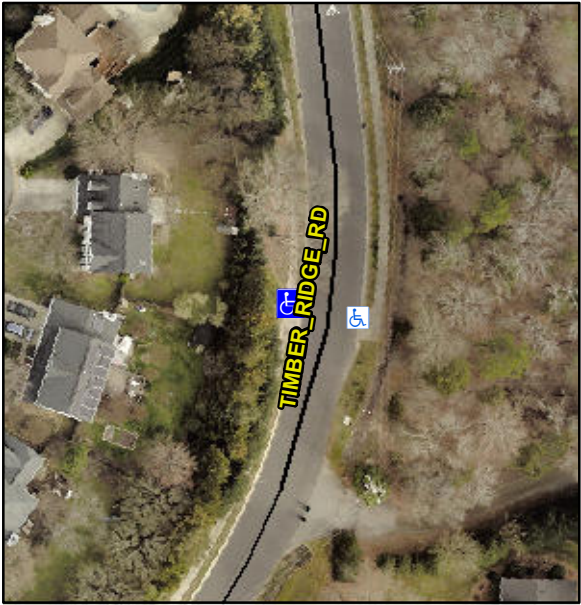
Possible Solutions:		Compliance	Description	Data
	Remove & Replace Entire Ramp.		Yes	Ramp Length (in)	49.5
			Yes	Ramp Width (in)	54.0
			N/A	Flare Type LT	Sloped
			N/A	Flare Slope LT (%)	3.7
			N/A	Flare Traversable LT?	No
			Yes	Landing Length (in)	48.0
			Yes	Landing Width (in)	55.0
			No	Landing Slope (%)	2.5
			No	Landing X Slope (%)	5.5
<p>Surveyor Notes:</p> <p>N/A</p> <p>PROW/ADA:</p> <p>Not Found, R304.2.2-Perp, R304.3.2-Para, R304.5.3, R305</p>			N/A	Flare Type RT	N/A
			N/A	Flare Slope RT (%)	5.1
			N/A	Flare Traversable RT?	No
			No	DWS Provided?	No
			N/A	DWS Contrast?	No
			N/A	DWS Length (in)	N/A
			N/A	DWS Full Width?	No
			N/A	DWS Offset (in)	N/A
			Yes	Shared Landing?	Yes
			Yes	Gutter Ponding?	No
<p>Total Cost:</p> <p>\$ 1850.00</p>			Yes	Gutter Lip Ht (in)	0.0
			N/A	Painted X Walk1?	No
				X Walk 1 Direction	To E

N/A	X Walk 1 Width (in)	N/A
				X Walk 1 Slope (%)	5.9
				X Walk 1 X Slope (%)	5.1
			N/A	Ramp inside XWalk1?	N/A
			N/A	Road Slope (%)	N/A
			N/A	Road X Slope (%)	N/A
			Yes	Any Obstructions?	No
				Obstruction Type	
			N/A		
			N/A		
			N/A	Clear Space?	Yes
			N/A	Clear Space to XWalk (in)	N/A
			Yes	Storm Grate/Utility Hazard?	No
				Storm Grate/Utility Type	
			N/A		N/A
			Yes	Surface Condition? (G/P)	Good
