# Access Compliance Report

## Public Rights-of-Way

### (Curb Ramps)

Intersection ID: 10034711	Main Street: POINDEXTER_DR	Cross Street: N/A	Location: S
ADA ID: FDE4FD4BC7FF	Ramp Type: Perp	Initial Pass/Fail: Fail	Overall Compliance: No
		Severity Score: 25

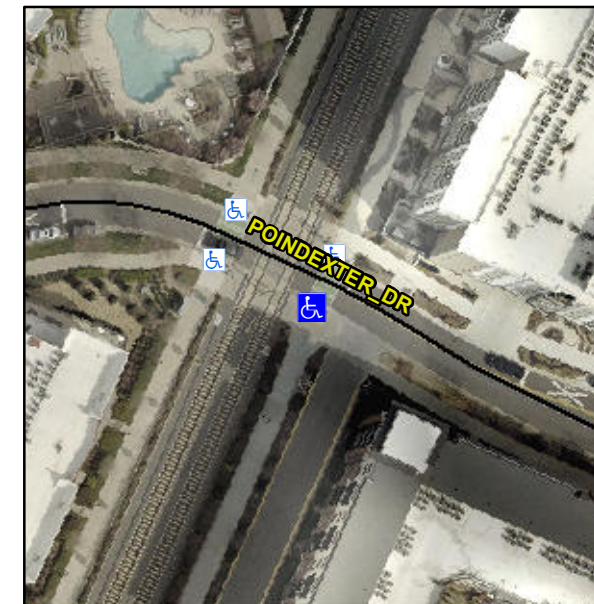
Compliance	Description	Data	Compliance	Description	Data
N/A	Ramp Length (in)	93.0	Yes	Ramp Slope (%)	5.6
Yes	Ramp Width (in)	137.0	No	Ramp XSlope (%)	7.3
N/A	Flare Type LT	N/A	N/A	Flare Type RT	N/A
N/A	Flare Slope LT (%)	N/A	N/A	Flare Slope RT (%)	N/A
N/A	Flare Traversable LT?	N/A	N/A	Flare Traversable RT?	N/A
N/A	Landing Length (in)	N/A	N/A	DWS Provided?	N/A
N/A	Landing Width (in)	N/A	N/A	DWS Contrast?	N/A
N/A	Landing Slope (%)	N/A	N/A	DWS Length (in)	N/A
N/A	Landing X Slope (%)	N/A	N/A	DWS Full Width?	N/A
N/A	Landing Curb? (Y/N)	N/A	N/A	DWS Offset (in)	N/A
N/A	Shared Landing?	N/A			
N/A	Gutter Ponding?	N/A	N/A	Gutter Slope (%)	N/A
N/A	Gutter Lip Ht (in)	N/A	N/A	Gutter X Slope (%)	N/A
N/A	Painted X Walk1?	Yes	N/A	Painted X Walk2?	N/A
	X Walk 1 Direction	To NE		X Walk 2 Direction	N/A
N/A	X Walk 1 Width (in)	136.0	N/A	X Walk 2 Width (in)	N/A
	X Walk 1 Slope (%)	1.4		X Walk 2 Slope (%)	N/A
	X Walk 1 X Slope (%)	2.4		X Walk 2 X Slope (%)	N/A

N/A	Ramp inside XWalk1?	Yes	N/A	Ramp inside XWalk2?	N/A
	Road Slope (%)	N/A	N/A	Clear Space?	N/A
	Road X Slope (%)	N/A	N/A	Clear Space to XWalk (in)	N/A
N/A	Any Obstructions?	N/A	N/A	Storm Grate/Utility Hazard?	N/A
	Obstruction Type			Storm Grate/Utility Type	
		N/A			N/A
			Yes	Surface Condition? (G/P)	Good

**Remove & Replace Entire Ramp.**
