Access Compliance Report

Public Rights-of-Way

(Curb Ramps)

Intersection ID: N/A	Main Street: SOUTHGROVE_ST	Cross Street: WAVERLY_WALK_AV	Location: SW
ADA ID: FDEEA7C08BC4	Ramp Type: Perp	Initial Pass/Fail: Fail	Overall Compliance: No
Severity Score: 1.25			
Codes/Mitigation Info/Possible Solution		Field Measurements/Component Compliance

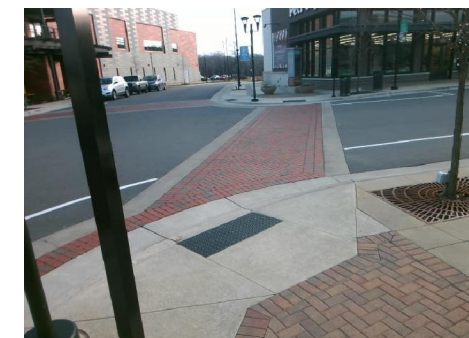
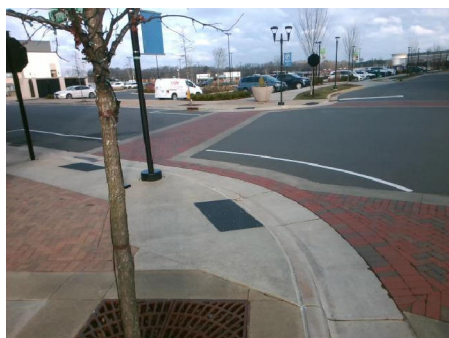
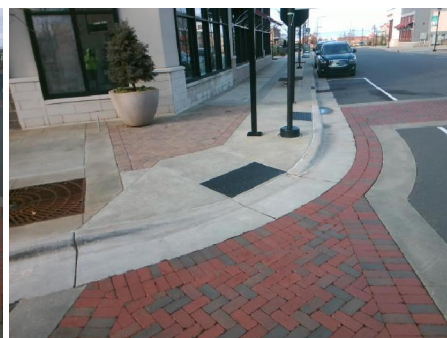
R304.5.3

Compliance	Description	Data	Compliance	Description	Data
N/A	Ramp Length (in)	71.0	Yes	Ramp Slope (%)	7.3
Yes	Ramp Width (in)	48.0	No	Ramp XSlope (%)	3.2
N/A	Flare Type LT	N/A	N/A	Flare Type RT	N/A
N/A	Flare Slope LT (%)	N/A	N/A	Flare Slope RT (%)	N/A
N/A	Flare Traversable LT?	N/A	N/A	Flare Traversable RT?	N/A
N/A	Landing Length (in)	N/A	N/A	DWS Provided?	N/A
N/A	Landing Width (in)	N/A	N/A	DWS Contrast?	N/A
N/A	Landing Slope (%)	N/A	N/A	DWS Length (in)	N/A
N/A	Landing X Slope (%)	N/A	N/A	DWS Full Width?	N/A
N/A	Landing Curb? (Y/N)	N/A	N/A	DWS Offset (in)	N/A
N/A	Shared Landing?	N/A			
N/A	Gutter Ponding?	N/A	N/A	Gutter Slope (%)	N/A
N/A	Gutter Lip Ht (in)	N/A	N/A	Gutter X Slope (%)	N/A
N/A	Painted X Walk1?	Yes	N/A	Painted X Walk2?	N/A
	X Walk 1 Direction	To E		X Walk 2 Direction	N/A
N/A	X Walk 1 Width (in)	104.3	N/A	X Walk 2 Width (in)	N/A
	X Walk 1 Slope (%)	1.0		X Walk 2 Slope (%)	N/A
	X Walk 1 X Slope (%)	0.5		X Walk 2 X Slope (%)	N/A

N/A	Ramp inside XWalk1?	Yes	N/A	Ramp inside XWalk2?	N/A
	Road Slope (%)	N/A	N/A	Clear Space?	N/A
	Road X Slope (%)	N/A	N/A	Clear Space to XWalk (in)	N/A
N/A	Any Obstructions?	N/A	N/A	Storm Grate/Utility Hazard?	N/A
	Obstruction Type			Storm Grate/Utility Type	
		N/A			N/A
			Yes	Surface Condition? (G/P)	Good

Remove & Replace Entire Ramp.

\$ 1850.00
