Access Compliance Report

Public Rights-of-Way

(Curb Ramps)

Intersection ID: 2457	Main Street: CAMBELLTON_DR	Cross Street: CLARKE_CREEK_PY	Location: NW
ADA ID: FDF33E472C60	Ramp Type: PerpDiag	Initial Pass/Fail: Fail	Overall Compliance: No Severity Score: 33.75

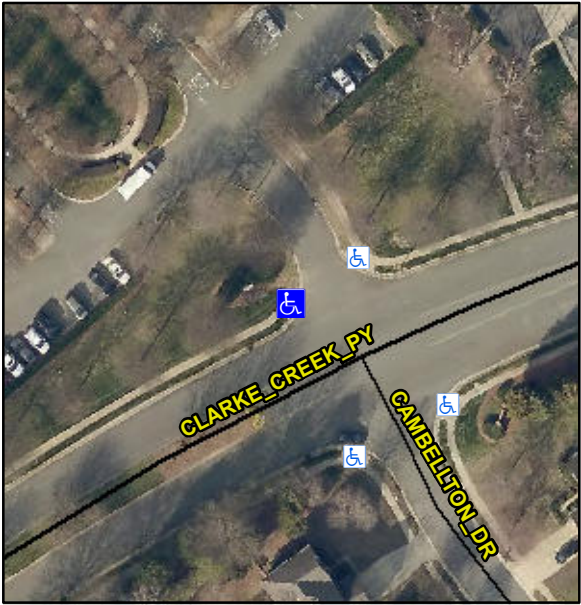
Possible Solutions:		Compliance	Description	Data
	Remove & Replace Curb Ramp With Two New Directional Ramps or Equivalent.		No	Ramp Length (in)	47.0
			No	Ramp Width (in)	43.0
			N/A	Flare Type LT	N/A
			N/A	Flare Slope LT (%)	N/A
			N/A	Flare Traversable LT?	N/A
			N/A	Landing Length (in)	N/A
			N/A	Landing Width (in)	N/A
			N/A	Landing Slope (%)	N/A
			N/A	Landing X Slope (%)	N/A
			N/A	Landing Curb? (Y/N)	N/A
			N/A	Shared Landing?	N/A
			N/A	Gutter Ponding?	N/A
			N/A	Gutter Lip Ht (in)	N/A
			No	Painted X Walk1?	N/A
				X Walk 1 Direction	To S
			N/A	X Walk 1 Width (in)	N/A
				X Walk 1 Slope (%)	4.8
				X Walk 1 X Slope (%)	3.3
			N/A	Ramp inside XWalk1?	N/A
<p>Surveyor Notes:</p> <p>N/A</p> <p>PROW/ADA:</p> <p>R304.5.1, R304.2.2, R304.5.3</p>			N/A	Flare Type RT	N/A
			N/A	Flare Slope RT (%)	N/A
			N/A	Flare Traversable RT?	N/A
