# Access Compliance Report

## Public Rights-of-Way

### (Curb Ramps)

Intersection ID: 18011	Main Street: PARK_RD	Cross Street: HEATHER_LN	Location: SW
ADA ID: FE06899EE011	Ramp Type: BlendTrans2	Initial Pass/Fail: Fail	Overall Compliance: No
		Severity Score: 17.5

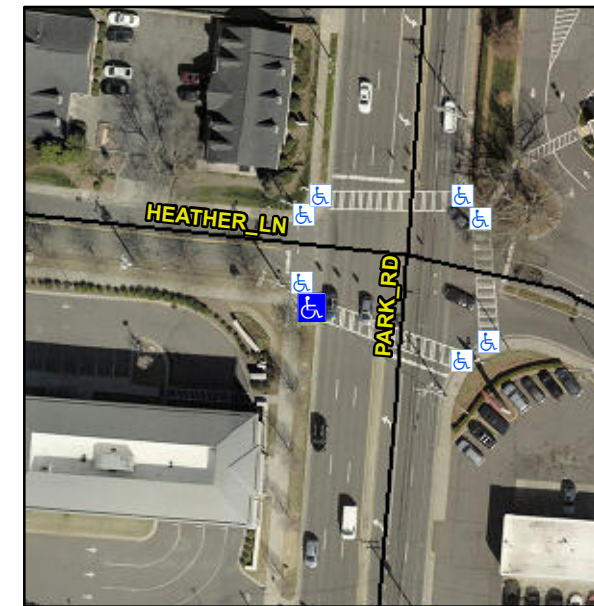
**Not Found, R304.5.1**

Compliance	Description	Data	Compliance	Description	Data
N/A	Ramp Length (in)	99.0	Yes	BlendTrans Slope (%)	0.9
No	Ramp Width (in)	32.0	Yes	BlendTrans XSlope (%)	1.6
N/A	Flare Type LT	N/A	N/A	Flare Type RT	N/A
N/A	Flare Slope LT (%)	N/A	N/A	Flare Slope RT (%)	N/A
N/A	Flare Traversable LT?	N/A	N/A	Flare Traversable RT?	N/A
N/A	Landing Length (in)	N/A	N/A	DWS Provided?	N/A
N/A	Landing Width (in)	N/A	N/A	DWS Contrast?	N/A
N/A	Landing Slope (%)	N/A	N/A	DWS Length (in)	N/A
N/A	Landing X Slope (%)	N/A	N/A	DWS Full Width?	N/A
N/A	Landing Curb? (Y/N)	N/A	N/A	DWS Offset (in)	N/A
N/A	Shared Landing?	N/A			
N/A	Gutter Ponding?	N/A	N/A	Gutter Slope (%)	N/A
N/A	Gutter Lip Ht (in)	N/A	N/A	Gutter X Slope (%)	N/A
N/A	Painted X Walk1?	Yes	N/A	Painted X Walk2?	N/A
	X Walk 1 Direction	To SE		X Walk 2 Direction	N/A
	X Walk 1 Width (in)	109.0		X Walk 2 Width (in)	N/A
	X Walk 1 Slope (%)	0.0		X Walk 2 Slope (%)	N/A
	X Walk 1 X Slope (%)	1.9		X Walk 2 X Slope (%)	N/A

N/A	Ramp inside XWalk1?	Yes	N/A	Ramp inside XWalk2?	N/A
	Road Slope (%)	1.9		Clear Space?	N/A
	Road X Slope (%)	0.0	N/A	Clear Space to XWalk (in)	N/A
N/A	Any Obstructions?	N/A	N/A	Storm Grate/Utility Hazard?	N/A
	Obstruction Type			Storm Grate/Utility Type	
		N/A			N/A
			Yes	Surface Condition? (G/P)	Good
			No	Curb Slope (%)	12.0

**Remove & Replace Curb Ramp With Two New Directional Ramps or Equivalent.**
