# Access Compliance Report

## Public Rights-of-Way

### (Curb Ramps)

Intersection ID: 42494	Main Street: BULLOCK GREENWAY BV	Cross Street: TOLLESON AV	Location: NE
ADA ID: FE0D16212D55	Ramp Type: PerpDiag	Initial Pass/Fail: Fail	Overall Compliance: No
Severity Score: 22.5			
Codes/Mitigation Info/Possible Solution		Field Measurements/Component Compliance

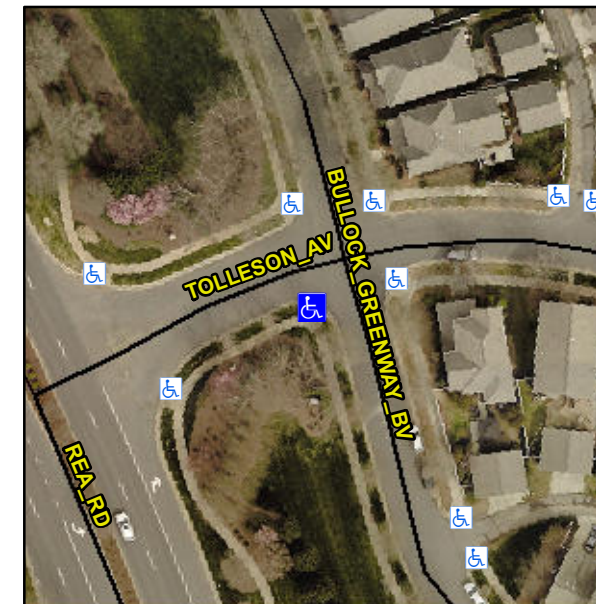
Compliance	Description	Data	Compliance	Description	Data
N/A	Ramp Length (in)	74.0	No	Ramp Slope (%)	8.6
No	Ramp Width (in)	43.0	No	Ramp XSlope (%)	2.5
N/A	Flare Type LT	N/A	N/A	Flare Type RT	N/A
N/A	Flare Slope LT (%)	N/A	N/A	Flare Slope RT (%)	N/A
N/A	Flare Traversable LT?	N/A	N/A	Flare Traversable RT?	N/A
N/A	Landing Length (in)	N/A	N/A	DWS Provided?	N/A
N/A	Landing Width (in)	N/A	N/A	DWS Contrast?	N/A
N/A	Landing Slope (%)	N/A	N/A	DWS Length (in)	N/A
N/A	Landing X Slope (%)	N/A	N/A	DWS Full Width?	N/A
N/A	Landing Curb? (Y/N)	N/A	N/A	DWS Offset (in)	N/A
N/A	Shared Landing?	N/A			
N/A	Gutter Ponding?	N/A	N/A	Gutter Slope (%)	N/A
N/A	Gutter Lip Ht (in)	N/A	N/A	Gutter X Slope (%)	N/A
N/A	Painted X Walk1?	No	N/A	Painted X Walk2?	No
	X Walk 1 Direction	To E		X Walk 2 Direction	To N
N/A	X Walk 1 Width (in)	N/A	N/A	X Walk 2 Width (in)	N/A
	X Walk 1 Slope (%)	1.3		X Walk 2 Slope (%)	2.1
	X Walk 1 X Slope (%)	0.8		X Walk 2 X Slope (%)	2.6

N/A	Ramp inside XWalk1?	N/A	N/A	Ramp inside XWalk2?	N/A
	Road Slope (%)	0.9	N/A	Clear Space?	N/A
	Road X Slope (%)	0.1	N/A	Clear Space to XWalk (in)	N/A
N/A	Any Obstructions?	N/A	N/A	Storm Grate/Utility Hazard?	N/A
	Obstruction Type			Storm Grate/Utility Type	
		N/A			N/A
		Yes		Surface Condition? (G/P)	Good

Possible Solutions:

**Remove & Replace Curb Ramp With Two New Directional Ramps or Equivalent.**
