Access Compliance Report

Public Rights-of-Way

(Curb Ramps)

Intersection ID: 12267	Main Street: CENTRAL_AV	Cross Street: LOUISE_AV	Location: NW
ADA ID: FE1921A60F49	Ramp Type: Para	Initial Pass/Fail: Pass	Overall Compliance: No
Severity Score: 0			
Codes/Mitigation Info/Possible Solution		Field Measurements/Component Compliance

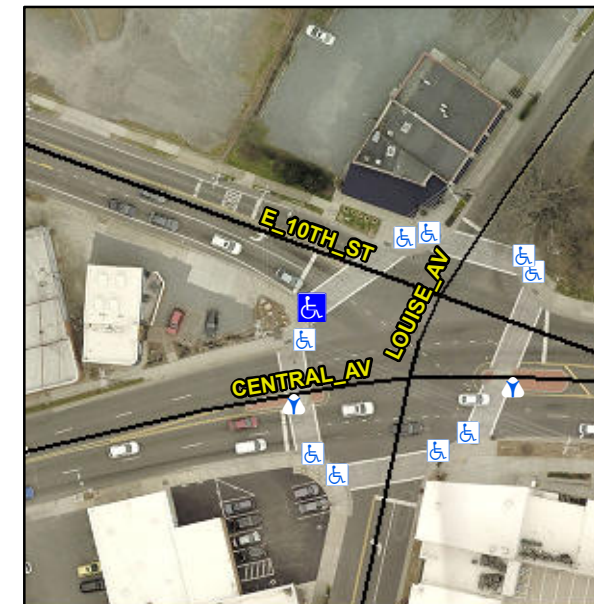
RT RP < 5%

Not Found, R304.2.1, R304.5.3, R305.2

Compliance	Description	Data	Compliance	Description	Data
N/A	Ramp Length LT (in)	42.5	N/A	Ramp Length RT (in)	48.0
Yes	Ramp Width LT (in)	72.0	Yes	Ramp Width RT (in)	72.0
Yes	Ramp Slope LT (%)	6.8	Yes	Ramp Slope RT (%)	0.0
Yes	Ramp XSlope LT (%)	0.5	Yes	Ramp XSlope RT (%)	1.8
Yes	Landing Length (in)	72.0	Yes	DWS Provided?	Yes
No	Landing Width (in)	42.0	Yes	DWS Contrast?	Yes
Yes	Landing Slope (%)	1.4	Yes	DWS Length (in)	24.0
No	Landing X Slope (%)	3.3	Yes	DWS Full Width?	Yes
N/A	Landing Curb? (Y/N)	No	No	DWS Offset (in)	5.5
N/A	Shared Landing?	No			
Yes	Gutter Ponding?	No	Yes	Gutter Slope (%)	4.6
Yes	Gutter Lip Ht (in)	0.0	Yes	Gutter X Slope (%)	2.6
N/A	Painted X Walk1?	Yes	N/A	Painted X Walk2?	N/A
	X Walk 1 Direction	To NE		X Walk 2 Direction	N/A
N/A	X Walk 1 Width (in)	144.0	N/A	X Walk 2 Width (in)	N/A
	X Walk 1 Slope (%)	3.3		X Walk 2 Slope (%)	N/A
	X Walk 1 X Slope (%)	3.1		X Walk 2 X Slope (%)	N/A
Yes	Ramp inside XWalk1?	Yes	N/A	Ramp inside XWalk2?	N/A

Road Slope (%)	N/A	N/A	Clear Space?	Yes
	Road X Slope (%)	N/A	N/A	Clear Space to XWalk (in)	N/A
Yes	Any Obstructions?	No	Yes	Storm Grate/Utility Hazard?	No
	Obstruction Type			Storm Grate/Utility Type	
		N/A			N/A
			Yes	Surface Condition? (G/P)	Good
			Replace	Curb Slope (%)	9.9

Possible Solutions:

Remove & Replace Entire Ramp.

Total Cost: \$ 1600.00
