# Access Compliance Report

## Public Rights-of-Way

### (Curb Ramps)

Intersection ID: 29684	Main Street: CAMERON_CREEK_DR	Cross Street: HAMPTON_GLEN_CT	Location: S
ADA ID: FE1AA78A6915	Ramp Type: PerpDiag	Initial Pass/Fail: Fail	Overall Compliance: No
Severity Score: 8.75			
Codes/Mitigation Info/Possible Solution		Field Measurements/Component Compliance

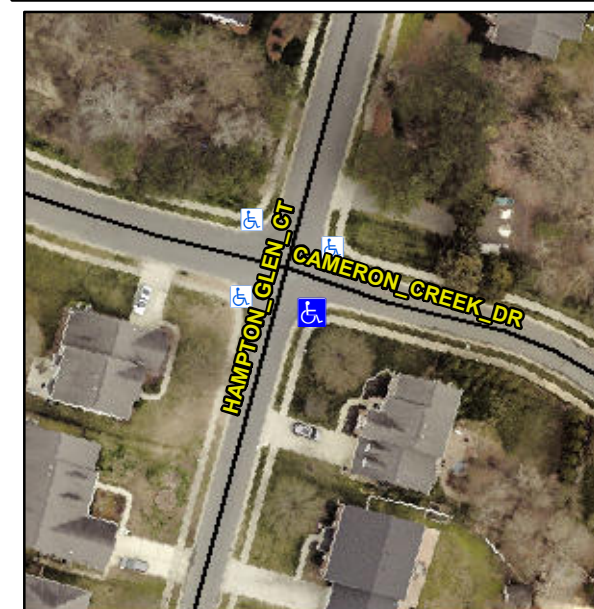
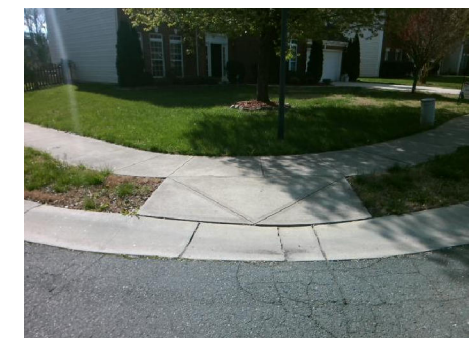
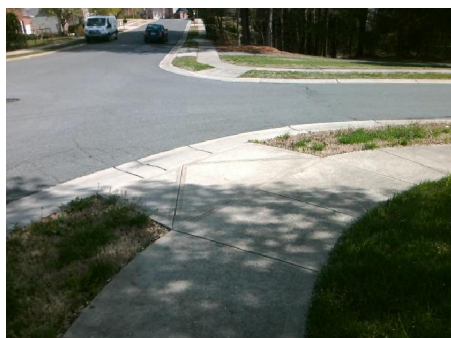
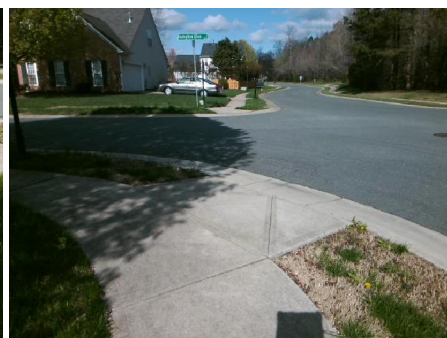
**Not Found, R304.5.1**

Compliance	Description	Data	Compliance	Description	Data
N/A	Ramp Length (in)	52.5	Yes	Ramp Slope (%)	5.6
No	Ramp Width (in)	44.0	Yes	Ramp XSlope (%)	0.2
N/A	Flare Type LT	N/A	N/A	Flare Type RT	N/A
N/A	Flare Slope LT (%)	N/A	N/A	Flare Slope RT (%)	N/A
N/A	Flare Traversable LT?	N/A	N/A	Flare Traversable RT?	N/A
N/A	Landing Length (in)	N/A	N/A	DWS Provided?	N/A
N/A	Landing Width (in)	N/A	N/A	DWS Contrast?	N/A
N/A	Landing Slope (%)	N/A	N/A	DWS Length (in)	N/A
N/A	Landing X Slope (%)	N/A	N/A	DWS Full Width?	N/A
N/A	Landing Curb? (Y/N)	N/A	N/A	DWS Offset (in)	N/A
N/A	Shared Landing?	N/A			
N/A	Gutter Ponding?	N/A	N/A	Gutter Slope (%)	N/A
N/A	Gutter Lip Ht (in)	N/A	N/A	Gutter X Slope (%)	N/A
N/A	Painted X Walk1?	No	N/A	Painted X Walk2?	No
	X Walk 1 Direction	To NE		X Walk 2 Direction	To NW
N/A	X Walk 1 Width (in)	N/A	N/A	X Walk 2 Width (in)	N/A
	X Walk 1 Slope (%)	2.2		X Walk 2 Slope (%)	3.2
	X Walk 1 X Slope (%)	2.8		X Walk 2 X Slope (%)	0.7

N/A	Ramp inside XWalk1?	N/A	N/A	Ramp inside XWalk2?	N/A
	Road Slope (%)	0.7	N/A	Clear Space?	N/A
	Road X Slope (%)	3.9	N/A	Clear Space to XWalk (in)	N/A
N/A	Any Obstructions?	N/A	N/A	Storm Grate/Utility Hazard?	N/A
	Obstruction Type			Storm Grate/Utility Type	
		N/A			N/A
			Yes	Surface Condition? (G/P)	Good

**Remove & Replace Curb Ramp With Two New Directional Ramps or Equivalent.**
