Access Compliance Report

Public Rights-of-Way

(Curb Ramps)

Intersection ID: 10022294	Main Street: CAMBRIDGE_GREEN_DR	Cross Street: N/A	Location: E
ADA ID: FE21D46DEBDA	Ramp Type: Perp	Initial Pass/Fail: Fail	Overall Compliance: No
Severity Score: 21.25			
Codes/Mitigation Info/Possible Solution		Field Measurements/Component Compliance

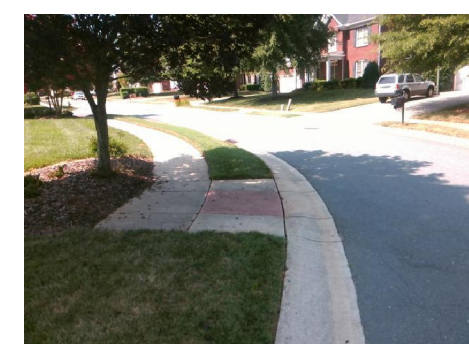
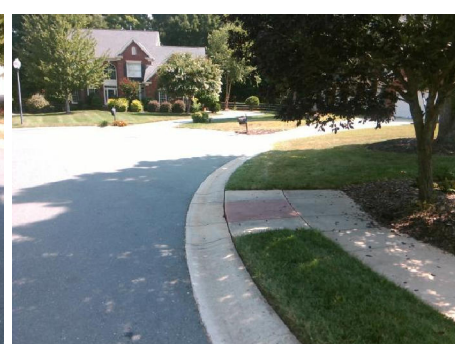
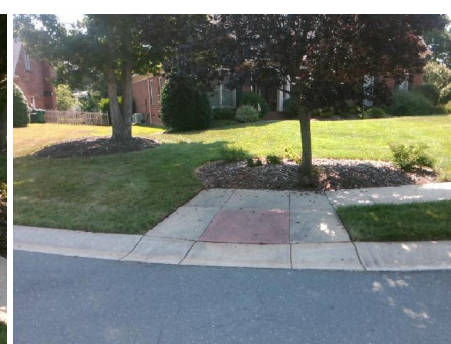
Compliance	Description	Data	Compliance	Description	Data
N/A	Ramp Length (in)	47.0	No	Ramp Slope (%)	10.9
No	Ramp Width (in)	44.0	Yes	Ramp XSlope (%)	2.0
N/A	Flare Type LT	N/A	N/A	Flare Type RT	N/A
N/A	Flare Slope LT (%)	N/A	N/A	Flare Slope RT (%)	N/A
N/A	Flare Traversable LT?	N/A	N/A	Flare Traversable RT?	N/A
N/A	Landing Length (in)	N/A	N/A	DWS Provided?	N/A
N/A	Landing Width (in)	N/A	N/A	DWS Contrast?	N/A
N/A	Landing Slope (%)	N/A	N/A	DWS Length (in)	N/A
N/A	Landing X Slope (%)	N/A	N/A	DWS Full Width?	N/A
N/A	Landing Curb? (Y/N)	N/A	N/A	DWS Offset (in)	N/A
N/A	Shared Landing?	N/A			
N/A	Gutter Ponding?	N/A	N/A	Gutter Slope (%)	N/A
N/A	Gutter Lip Ht (in)	N/A	N/A	Gutter X Slope (%)	N/A
N/A	Painted X Walk1?	No	N/A	Painted X Walk2?	N/A
	X Walk 1 Direction	To W		X Walk 2 Direction	N/A
N/A	X Walk 1 Width (in)	N/A	N/A	X Walk 2 Width (in)	N/A
	X Walk 1 Slope (%)	3.4		X Walk 2 Slope (%)	N/A
	X Walk 1 X Slope (%)	1.4		X Walk 2 X Slope (%)	N/A

N/A	Ramp inside XWalk1?	N/A	N/A	Ramp inside XWalk2?	N/A
	Road Slope (%)	N/A	N/A	Clear Space?	N/A
	Road X Slope (%)	N/A	N/A	Clear Space to XWalk (in)	N/A
N/A	Any Obstructions?	N/A	N/A	Storm Grate/Utility Hazard?	N/A
	Obstruction Type			Storm Grate/Utility Type	
		N/A			N/A
			Yes	Surface Condition? (G/P)	Good

Possible Solutions:

Remove & Replace Entire Ramp.
