Access Compliance Report

Public Rights-of-Way

(Curb Ramps)

Intersection ID: 10030374	Main Street: LEVINE AVENUE OF THE ARTS	Cross Street: N/A	Location: E
ADA ID: FE274BB787A2	Ramp Type: Perp	Initial Pass/Fail: Fail	Overall Compliance: No
Severity Score: 12.5			
Codes/Mitigation Info/Possible Solution		Field Measurements/Component Compliance

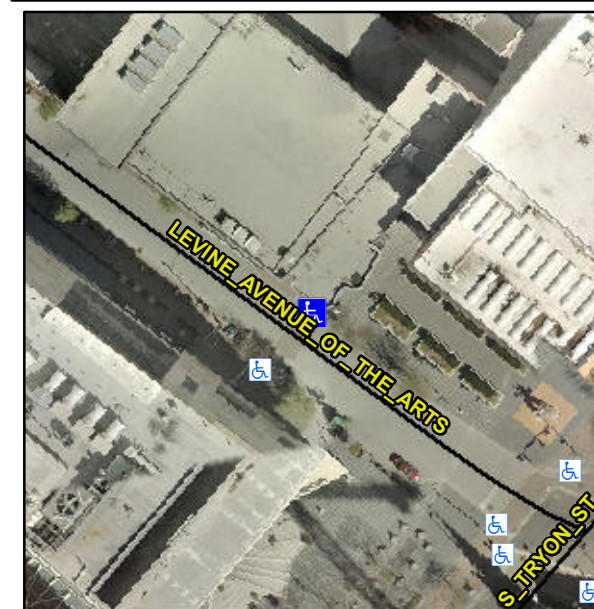
Compliance	Description	Data	Compliance	Description	Data
N/A	Ramp Length (in)	71.0	No	Ramp Slope (%)	10.0
Yes	Ramp Width (in)	59.0	Yes	Ramp XSlope (%)	1.7
N/A	Flare Type LT	N/A	N/A	Flare Type RT	N/A
N/A	Flare Slope LT (%)	N/A	N/A	Flare Slope RT (%)	N/A
N/A	Flare Traversable LT?	N/A	N/A	Flare Traversable RT?	N/A
N/A	Landing Length (in)	N/A	N/A	DWS Provided?	N/A
N/A	Landing Width (in)	N/A	N/A	DWS Contrast?	N/A
N/A	Landing Slope (%)	N/A	N/A	DWS Length (in)	N/A
N/A	Landing X Slope (%)	N/A	N/A	DWS Full Width?	N/A
N/A	Landing Curb? (Y/N)	N/A	N/A	DWS Offset (in)	N/A
N/A	Shared Landing?	N/A			
N/A	Gutter Ponding?	N/A	N/A	Gutter Slope (%)	N/A
N/A	Gutter Lip Ht (in)	N/A	N/A	Gutter X Slope (%)	N/A
N/A	Painted X Walk1?	Yes	N/A	Painted X Walk2?	N/A
	X Walk 1 Direction	To SW		X Walk 2 Direction	N/A
N/A	X Walk 1 Width (in)	150.0	N/A	X Walk 2 Width (in)	N/A
	X Walk 1 Slope (%)	2.3		X Walk 2 Slope (%)	N/A
	X Walk 1 X Slope (%)	1.1		X Walk 2 X Slope (%)	N/A

Possible Solutions:

Remove & Replace Entire Ramp.

R304.2.2

\$ 1850.00
