Access Compliance Report

Public Rights-of-Way

(Curb Ramps)

Intersection ID: 54043	Main Street: ELEVATION_POINT_DR	Cross Street: BALLANTYNE_GREEN_DR	Location: NW
ADA ID: FE3AE6F8D9F2	Ramp Type: Directional1	Initial Pass/Fail: Fail	Overall Compliance: No
Codes/Mitigation Info/Possible Solution		Field Measurements/Component Compliance	
Severity Score: 1.25

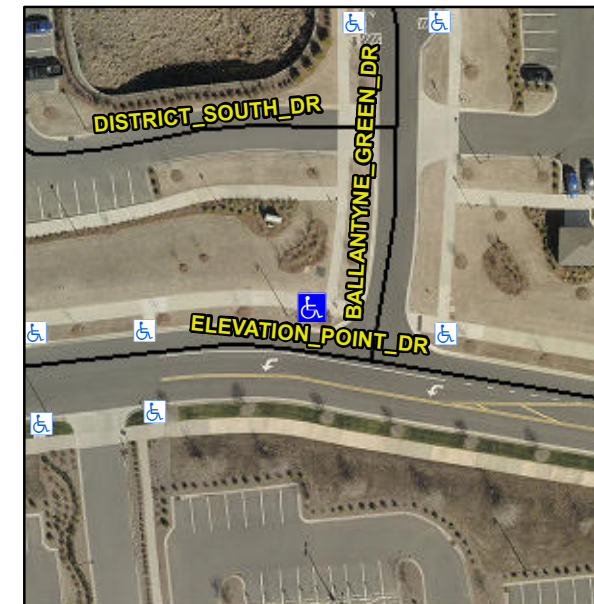
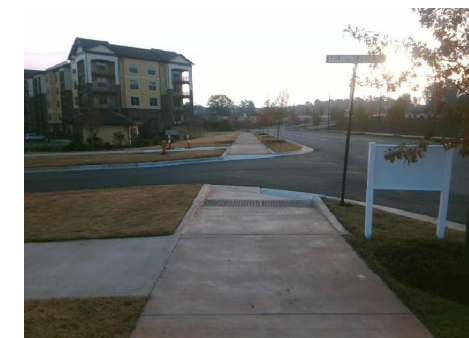
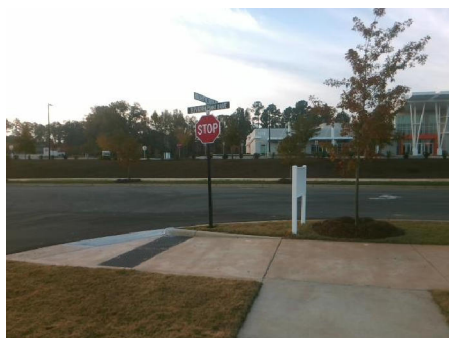
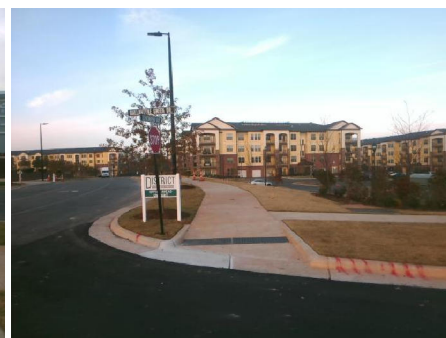
Compliance	Description	Data	Compliance	Description	Data
N/A	Ramp Length (in)	97.0	N/A	Grade Break?	N/A
Yes	Ramp Width (in)	92.0	N/A	Grade Break Slope (%)	0.0
Yes	Ramp Slope (%)	2.4	N/A	Grade Break XSlope (%)	0.0
No	Ramp XSlope (%)	2.6			
N/A	Flare Type LT	N/A	N/A	Flare Type RT	N/A
N/A	Flare Slope LT (%)	N/A	N/A	Flare Slope RT (%)	0.0
N/A	Flare Traversable LT?	N/A	N/A	Flare Traversable RT?	N/A
N/A	Landing Length (in)	0.0	N/A	DWS Provided?	N/A
N/A	Landing Width (in)	0.0	N/A	DWS Contrast?	N/A
N/A	Landing Slope (%)	0.0	N/A	DWS Length (in)	N/A
N/A	Landing X Slope (%)	0.0	N/A	DWS Full Width?	N/A
N/A	Landing Curb? (Y/N)	N/A	N/A	DWS Offset LT (in)	N/A
N/A	Shared Landing?	N/A	N/A	DWS Offset RT (in)	N/A
N/A	Gutter Ponding?	0.0	N/A	Gutter Slope (%)	N/A
N/A	Gutter Lip Ht (in)	0.0	N/A	Gutter X Slope (%)	N/A
N/A	Painted X Walk1?	No		Road Slope (%)	2.1
	X Walk 1 Direction	To E		Road X Slope (%)	0.2
	X Walk 1 Width (in)	N/A		Clear Space?	N/A

X Walk 1 Slope (%)	2.1	N/A	Clear Space to XWalk (in)	N/A
	X Walk 1 X Slope (%)	0.2	N/A	Storm Grate/Utility Hazard?	N/A
N/A	Ramp inside XWalk1?	N/A		Storm Grate/Utility Type	
N/A	Any Obstructions?	N/A			N/A
	Obstruction Type		Yes	Surface Condition? (G/P)	Good
			N/A	Curb Slope (%)	0.3

Possible Solutions:

Remove & Replace Entire Ramp.

R304.5.3
