Access Compliance Report

Public Rights-of-Way

(Curb Ramps)

| Intersection ID: 52249 | Main Street: PARK_RD | Cross Street: N/A | Location: W |

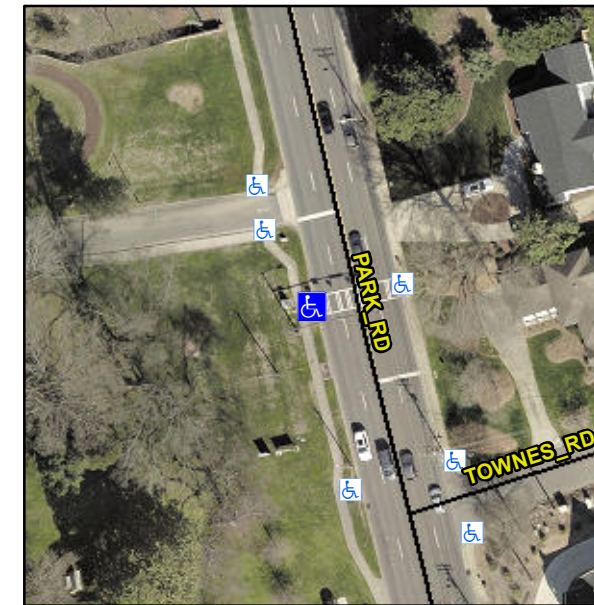
| ADA ID: FE3BF129D83A | Ramp Type: BlendTrans1 | Initial Pass/Fail: Fail | Overall Compliance: No |

| Compliance | Description | Data | Compliance | Description | Data |
|---|---|---|---|---|---|
| N/A | Ramp Length (in) | 59.0 | Yes | BlendTrans Slope (%) | 3.8 |
| No | Ramp Width (in) | 47.0 | No | BlendTrans XSlope (%) | 2.6 |

Remove & Replace Curb Ramp With Two New Directional Ramps or Equivalent.

R304.5.1, R304.5.3
