# Access Compliance Report

## Public Rights-of-Way (Curb Ramps)

Intersection ID: N/A	Main Street: INVERNESS_BAY_RD	Cross Street: PERTH_MOOR_RD	Location: SW
ADA ID: FE4D1E5467C3	Ramp Type: Perp	Initial Pass/Fail: Fail	Overall Compliance: No
Codes/Mitigation Info/Possible Solution		Field Measurements/Component Compliance	
Severity Score: 25

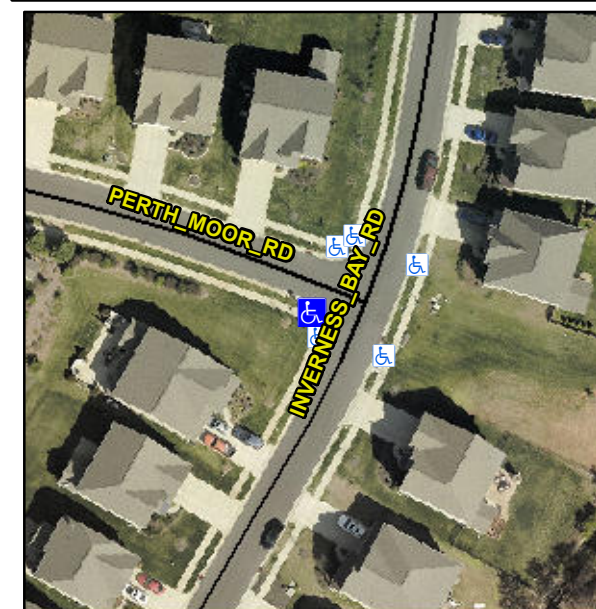
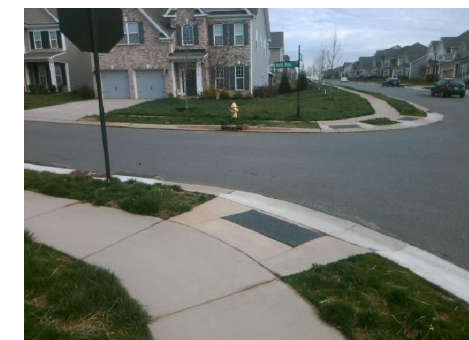
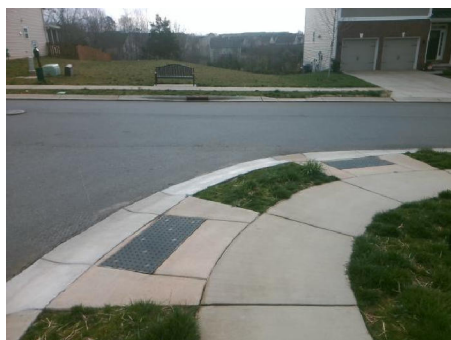
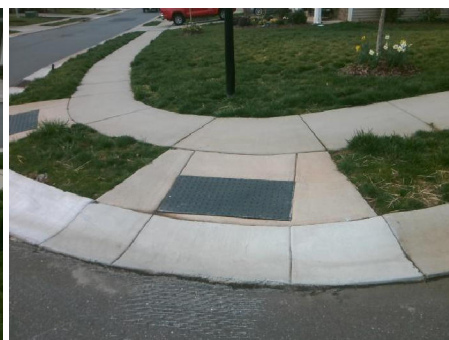
**Not Found, R304.2.2, R304.5.3**

Compliance	Description	Data	Compliance	Description	Data
N/A	Ramp Length (in)	48.0	No	Ramp Slope (%)	8.5
Yes	Ramp Width (in)	48.0	No	Ramp XSlope (%)	5.5
N/A	Flare Type LT	N/A	N/A	Flare Type RT	N/A
N/A	Flare Slope LT (%)	N/A	N/A	Flare Slope RT (%)	N/A
N/A	Flare Traversable LT?	N/A	N/A	Flare Traversable RT?	N/A
N/A	Landing Length (in)	N/A	N/A	DWS Provided?	N/A
N/A	Landing Width (in)	N/A	N/A	DWS Contrast?	N/A
N/A	Landing Slope (%)	N/A	N/A	DWS Length (in)	N/A
N/A	Landing X Slope (%)	N/A	N/A	DWS Full Width?	N/A
N/A	Landing Curb? (Y/N)	N/A	N/A	DWS Offset (in)	N/A
N/A	Shared Landing?	N/A			
N/A	Gutter Ponding?	N/A	N/A	Gutter Slope (%)	N/A
N/A	Gutter Lip Ht (in)	1.0	N/A	Gutter X Slope (%)	N/A
N/A	Painted X Walk1?	No	N/A	Painted X Walk2?	N/A
	X Walk 1 Direction	To NE		X Walk 2 Direction	N/A
N/A	X Walk 1 Width (in)	N/A	N/A	X Walk 2 Width (in)	N/A
	X Walk 1 Slope (%)	6.2		X Walk 2 Slope (%)	N/A
	X Walk 1 X Slope (%)	0.9		X Walk 2 X Slope (%)	N/A

N/A	Ramp inside XWalk1?	N/A	N/A	Ramp inside XWalk2?	N/A
	Road Slope (%)	N/A	N/A	Clear Space?	N/A
	Road X Slope (%)	N/A	N/A	Clear Space to XWalk (in)	N/A
N/A	Any Obstructions?	N/A	N/A	Storm Grate/Utility Hazard?	N/A
	Obstruction Type			Storm Grate/Utility Type	
		N/A			N/A
			Yes	Surface Condition? (G/P)	Good

**Remove & Replace Entire Ramp.**

Total Cost: \$ 1850.00
