# Access Compliance Report

## Public Rights-of-Way

### (Curb Ramps)

Intersection ID: 14295	Main Street: E_PARK_AV	Cross Street: WINTHROP_AV	Location: NE
ADA ID: FE4F8D371B69	Ramp Type: PerpDiag	Initial Pass/Fail: Fail	Overall Compliance: No
			Severity Score: 26.25

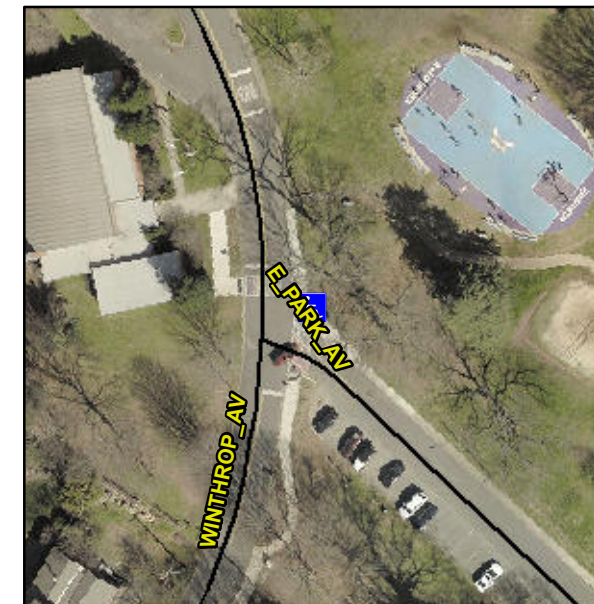
**Not Found, R304.2.2, R304.5.3**

Compliance	Description	Data	Compliance	Description	Data
N/A	Ramp Length (in)	38.0	No	Ramp Slope (%)	16.8
Yes	Ramp Width (in)	48.0	No	Ramp XSlope (%)	4.4
N/A	Flare Type LT	N/A	N/A	Flare Type RT	N/A
N/A	Flare Slope LT (%)	N/A	N/A	Flare Slope RT (%)	N/A
N/A	Flare Traversable LT?	N/A	N/A	Flare Traversable RT?	N/A
N/A	Landing Length (in)	N/A	N/A	DWS Provided?	N/A
N/A	Landing Width (in)	N/A	N/A	DWS Contrast?	N/A
N/A	Landing Slope (%)	N/A	N/A	DWS Length (in)	N/A
N/A	Landing X Slope (%)	N/A	N/A	DWS Full Width?	N/A
N/A	Landing Curb? (Y/N)	N/A	N/A	DWS Offset (in)	N/A
N/A	Shared Landing?	N/A			
N/A	Gutter Ponding?	N/A	N/A	Gutter Slope (%)	N/A
N/A	Gutter Lip Ht (in)	N/A	N/A	Gutter X Slope (%)	N/A
N/A	Painted X Walk1?	No	N/A	Painted X Walk2?	No
	X Walk 1 Direction	To W		X Walk 2 Direction	To S
N/A	X Walk 1 Width (in)	N/A	N/A	X Walk 2 Width (in)	N/A
	X Walk 1 Slope (%)	3.7		X Walk 2 Slope (%)	6.2
	X Walk 1 X Slope (%)	4.2		X Walk 2 X Slope (%)	3.4

N/A	Ramp inside XWalk1?	N/A	N/A	Ramp inside XWalk2?	N/A
	Road Slope (%)	3.7	N/A	Clear Space?	N/A
	Road X Slope (%)	5.2	N/A	Clear Space to XWalk (in)	N/A
N/A	Any Obstructions?	N/A	N/A	Storm Grate/Utility Hazard?	N/A
	Obstruction Type			Storm Grate/Utility Type	
		N/A			N/A
			Yes	Surface Condition? (G/P)	Good

**Remove & Replace Curb Ramp With Two New Directional Ramps or Equivalent.**
